# HUMBOLDT COASTAL RESILIENCY PROJECT AND CLIMATE READY PROJECT

## SUMMARY DATA FOR CROSS-SHORE TRANSECTS WINTER 2016-SUMMER 2020

Andrea Pickart and Candace Reynolds, U.S. Fish and Wildlife Service,  
and Ian Walker, U.C. Santa Barbara

July 2021

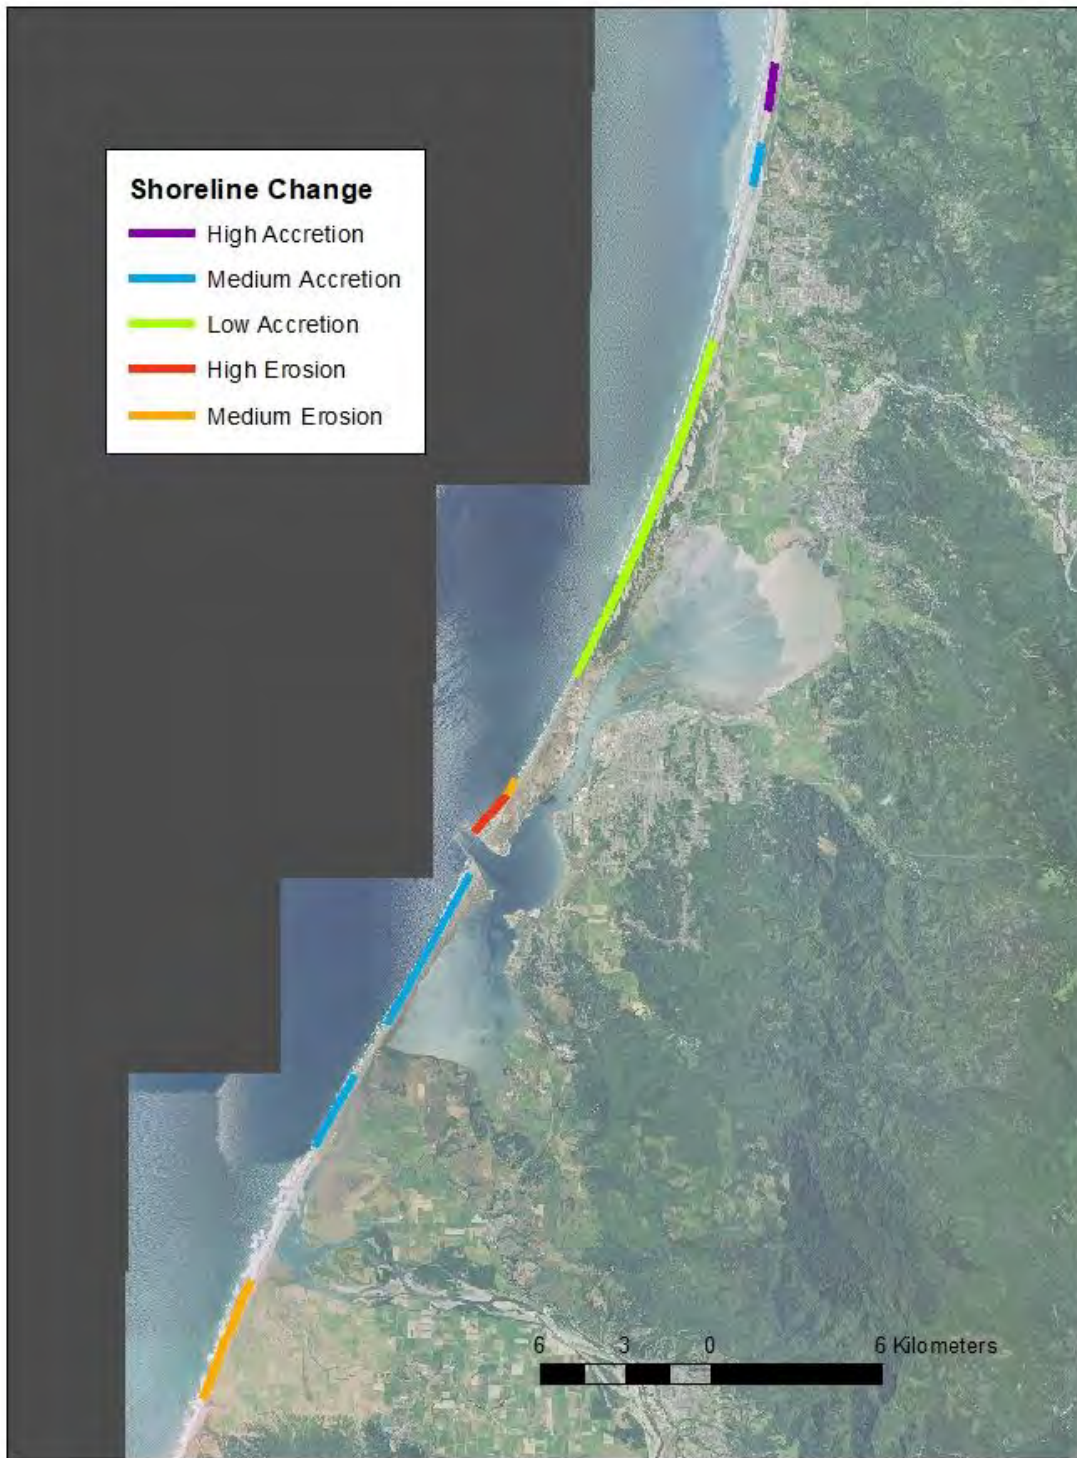
**HISTORIC SHORELINE CHANGE MAP.** This map illustrates historic change in shoreline position from 1939/1948 through 2016 based on McDonald (2017) and GHD (2017).

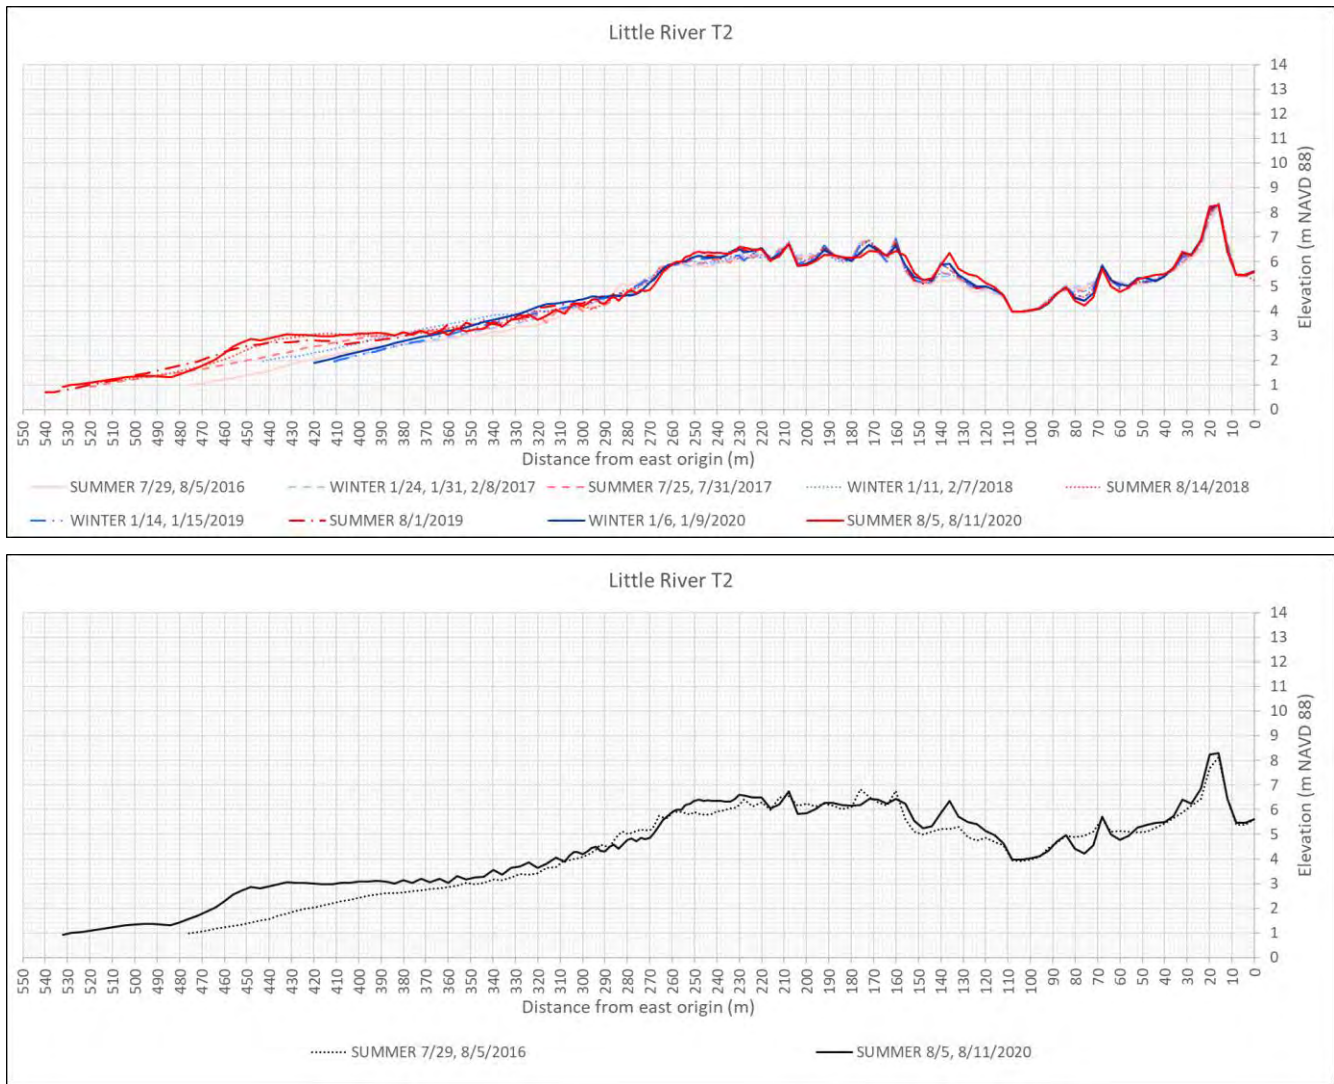
## Little River Transect 2

Notes: Similar to Transect 1 and located in an area of Little River State Beach restored through the removal of *Ammophila* by heavy equipment. Transects show a winter flattening of the backshore by storm wave runoff, erosion, and deposition, followed by development of transverse dunes in summer, with net accretion of up to 1.2 m on the lower beach between summer 2016 and summer 2020. The backshore gradually rises in elevation and transitions to a broad plateau-like nebkha field. Nebkha show both flattening (see photo below) and in some areas development of new slipfaces between summer 2016 and summer 2020. Maximum elevation of the nebkha zone along the transect is 6.7 m NAVD 88. The transect then extends through the deflation plain where there was both erosion and accretion in summer 2018. There is an abrupt peak at a relict, unrestored foredune (16 m) where *Ammophila* is continuing to trap sediments from the deflation plain. Over the course of the study there was net deposition both on the beach and in the nebkha field.

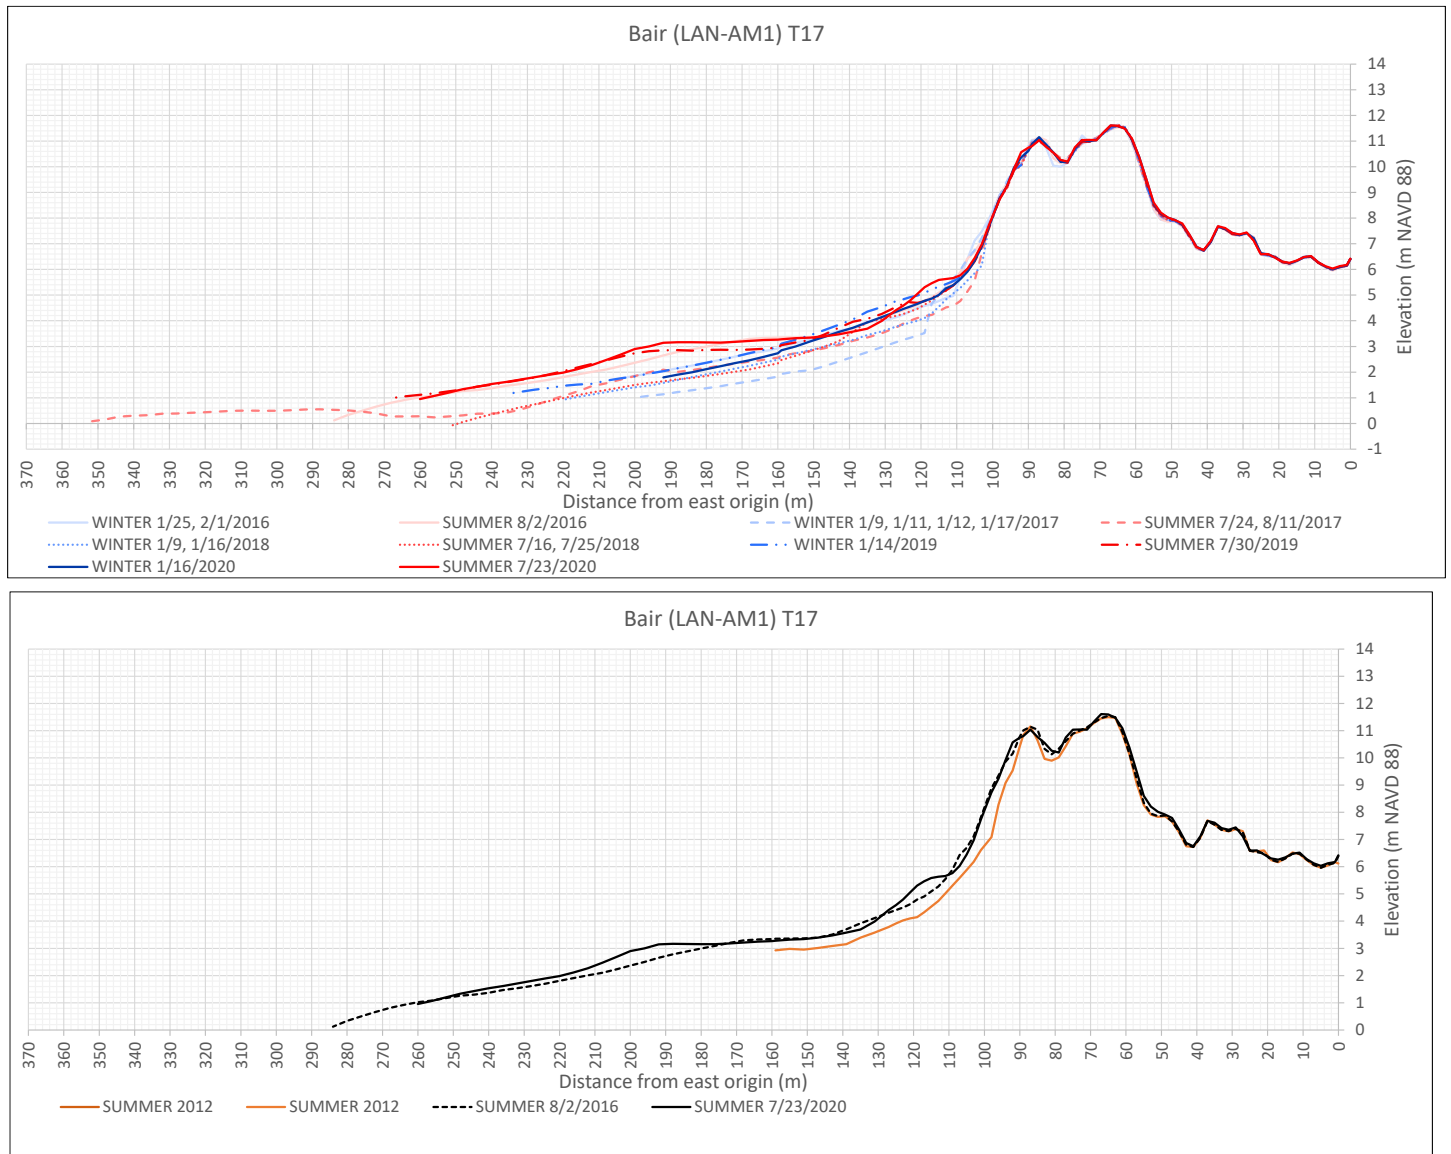
## Bair Transect 17

Notes: Between 2012 and 2016 there was deposition of 0.5 m on the stoss slope of the foredune. Significant scarping of the established foredune and lowering of the beach occurred in 2016 prior to the winter 2016 survey (no incipient foredune was present). By summer 2016 a combination of slumping and ramping had smoothed the foredune slope. By the time of the winter 2017 survey the upper beach had scarped and lowered 1.0 m, and shortly after a large highwater event scarped the foredune back 10.0 m horizontally. By summer 2017 the beach had accreted 0.5 m vertically, but the ramp was only just reaching the base of the scarp. Therefore, sand transport from the beach to the foredune was limited during this season. Between summer 2017 and summer 2018 the foredune toe had regained elevation and the ramp was fully formed, allowing sand transport from the beach to the foredune. This transect is located in the Lanphere Adaptation Site, where *Ammophila* was removed from the foredune in winter 2016, and native species planted in winter 2017. Post vegetation removal, the first foredune crest deflated approximately 0.2 m, with sand deposited in the swale between the two foredune crests. As vegetation became established there was little change in this area from summer 2017 to summer 2018. The foredune base and ramp changed little between 2018 and 2019. Over the course of the study, and in response to restoration treatments, the foredune broadened with net deposition on both the upper stoss and lee slopes and steepening of the lower stoss face, but with limited change in position and elevation of the crest.

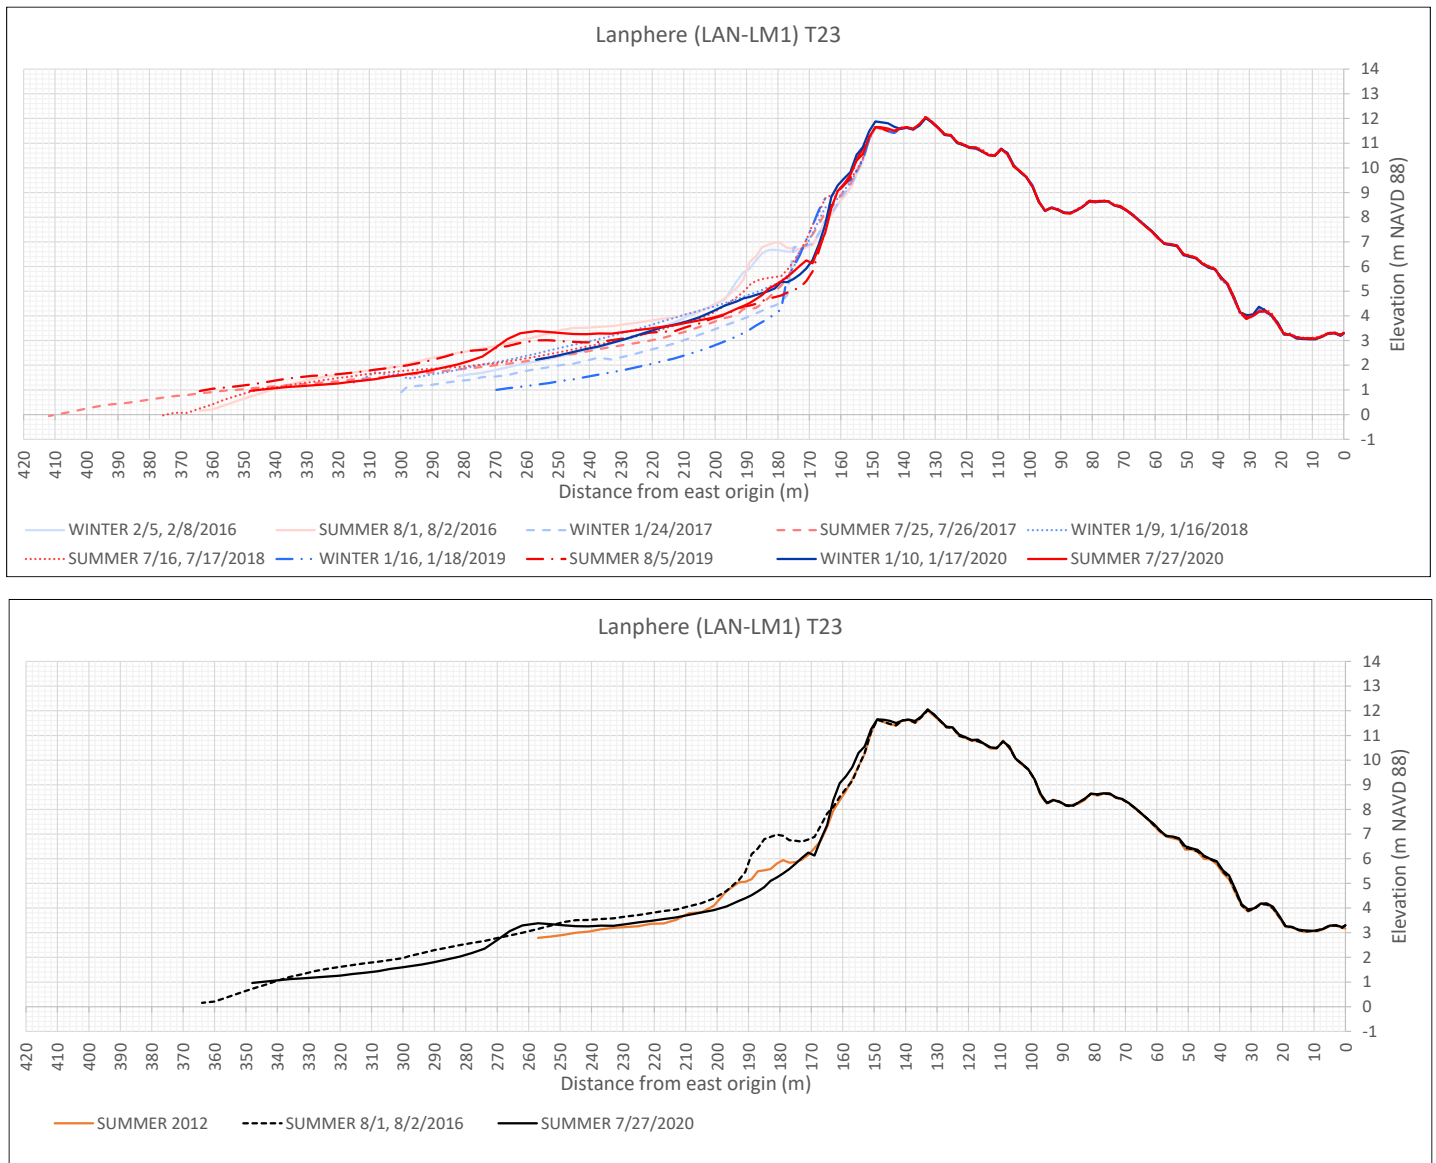
## Lanphere Dunes Transect 23

Notes: This is a high (12.0 m NAVD 88), native, established foredune with a dynamic incipient foredune. The incipient foredune formed between 2012 and 2016, and was stable for the first year while the beach underwent seasonal changes. In winter 2017, prior to the survey, the incipient foredune was entirely removed through a dramatic 2.0 m vertical scarping event that resulted in 20 m of retreat. By summer 2018, the beach had recovered some of its elevation especially on the backshore. Between winter and summer 2019 the established foredune scarped, retreating 8 m at its base. By 2020 a ramp was forming, and there was deposition on the stoss face of the foredune. Over the course of both studies the incipient foredune was formed and then eroded, retreating over 30.0 m, and the upper stoss face accreted.

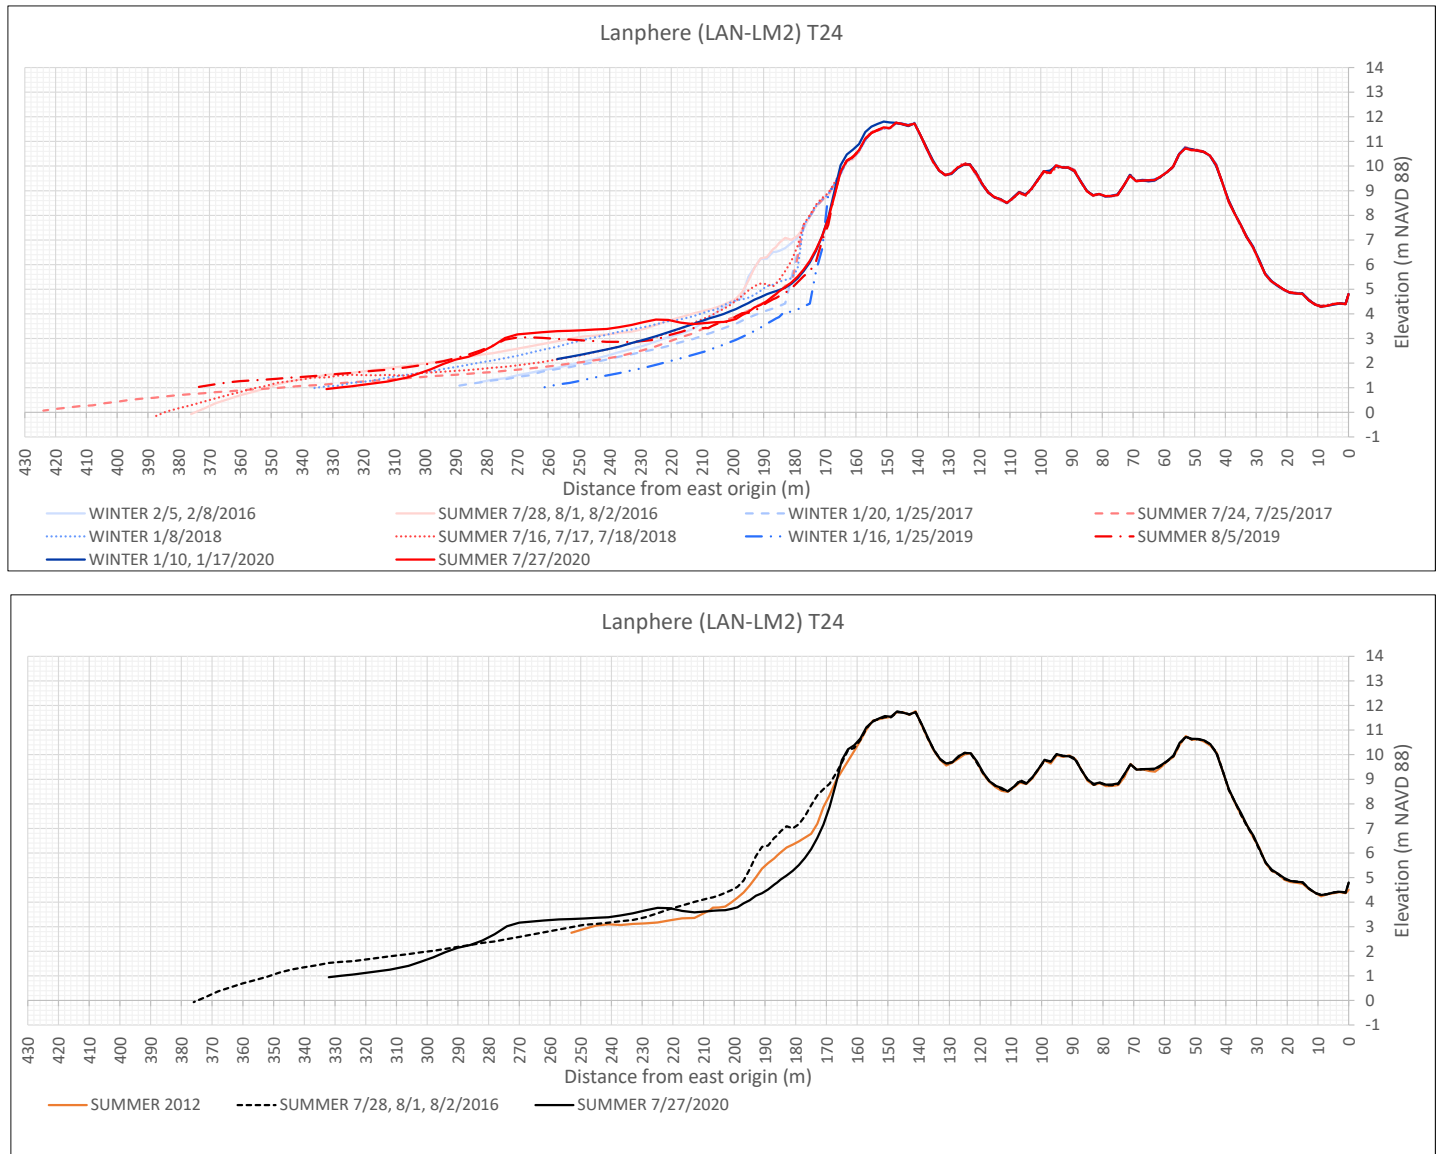
## Lanphere Dunes Transect 24

Notes: The incipient foredune was formed between 2012 and 2016, and was entirely removed in winter 2017 prior to the survey. High water events led to a 2.0 m vertical elevation loss, and 17 m of retreat. By 2018 ramping had occurred at the base of the foredune. In winter 2019 the established foredune scarped back 10 m, although by summer 2019 deposition of +1 m had occurred on the upper beach. By 2020 a ramp was forming on the scarp (see photo). Over the course of both studies the incipient foredune was formed and then removed, retreating over 20.0 m, and the established foredune eroded on its stoss face, but was showing signs of recovery through scarp-fill ramping.

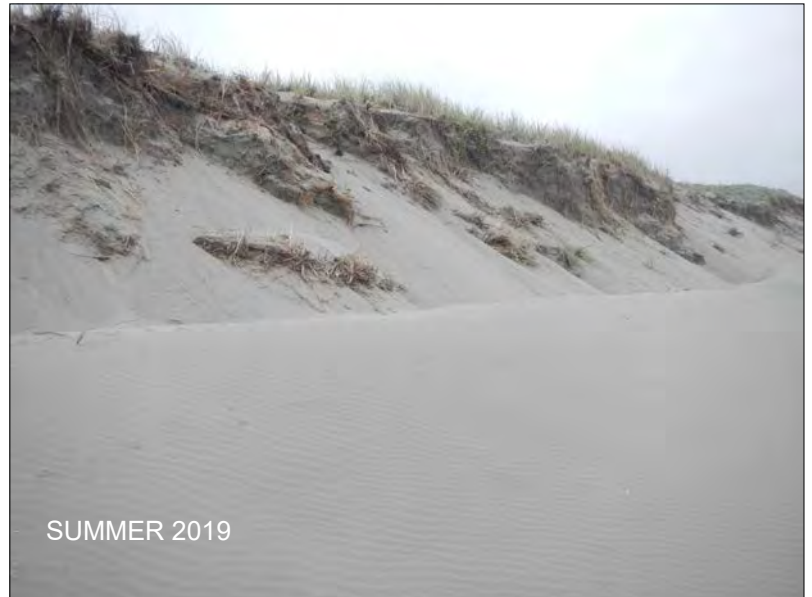
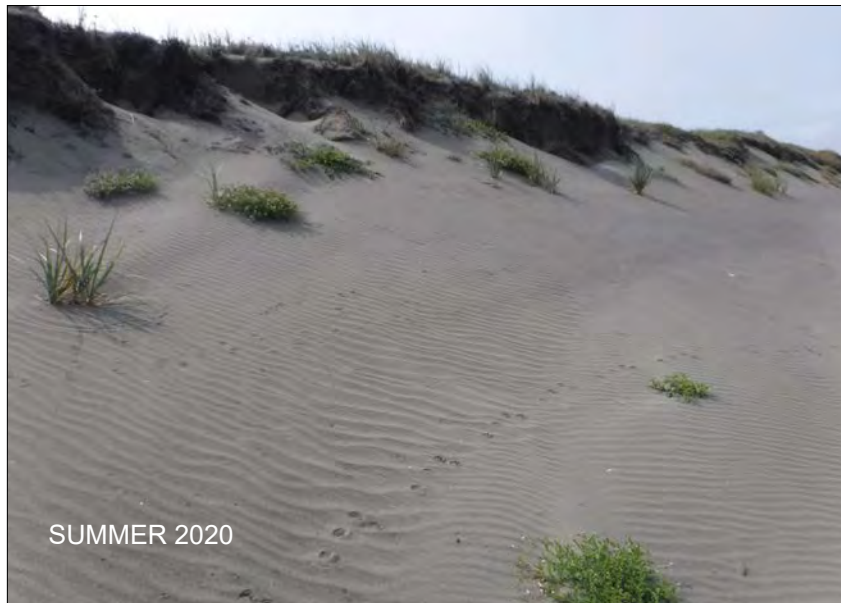
View southeast of scarp at 183 m.

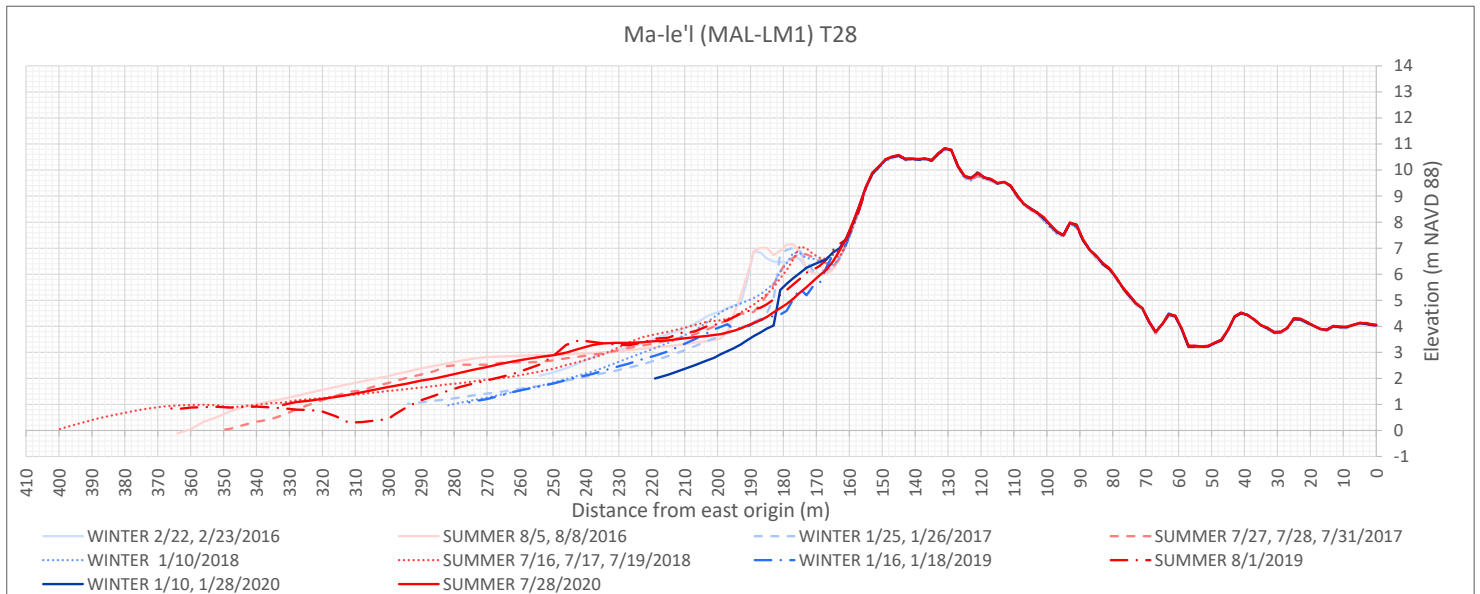
## Ma-le'I North Transect 28

Notes: Between 2012 and 2016 (prior to this study), an incipient foredune formed. A 2.0 m vertical scarp occurred in the incipient *Elymus* foredune in winter 2016. By summer 2016 the scarp had increased in height from further erosion and sand at the top of the scarp mobilized, forming a slipface. In winter 2017 the incipient foredune re-scarped, retreating an additional 10.0 m, and up to 10.0 m of sediment eroded from the backshore. By summer 2017 the crest of the incipient foredune had migrated inland, de-emphasizing the incipient foredune swale. The beach regained elevation to near the level of summer 2016. Between summer 2017 and summer 2018 the incipient foredune remained relatively unchanged (see photos). However, in 2019 the incipient foredune was entirely removed. Over the course of both studies the established foredune was stable, but the incipient foredune was first formed and then completely eroded.

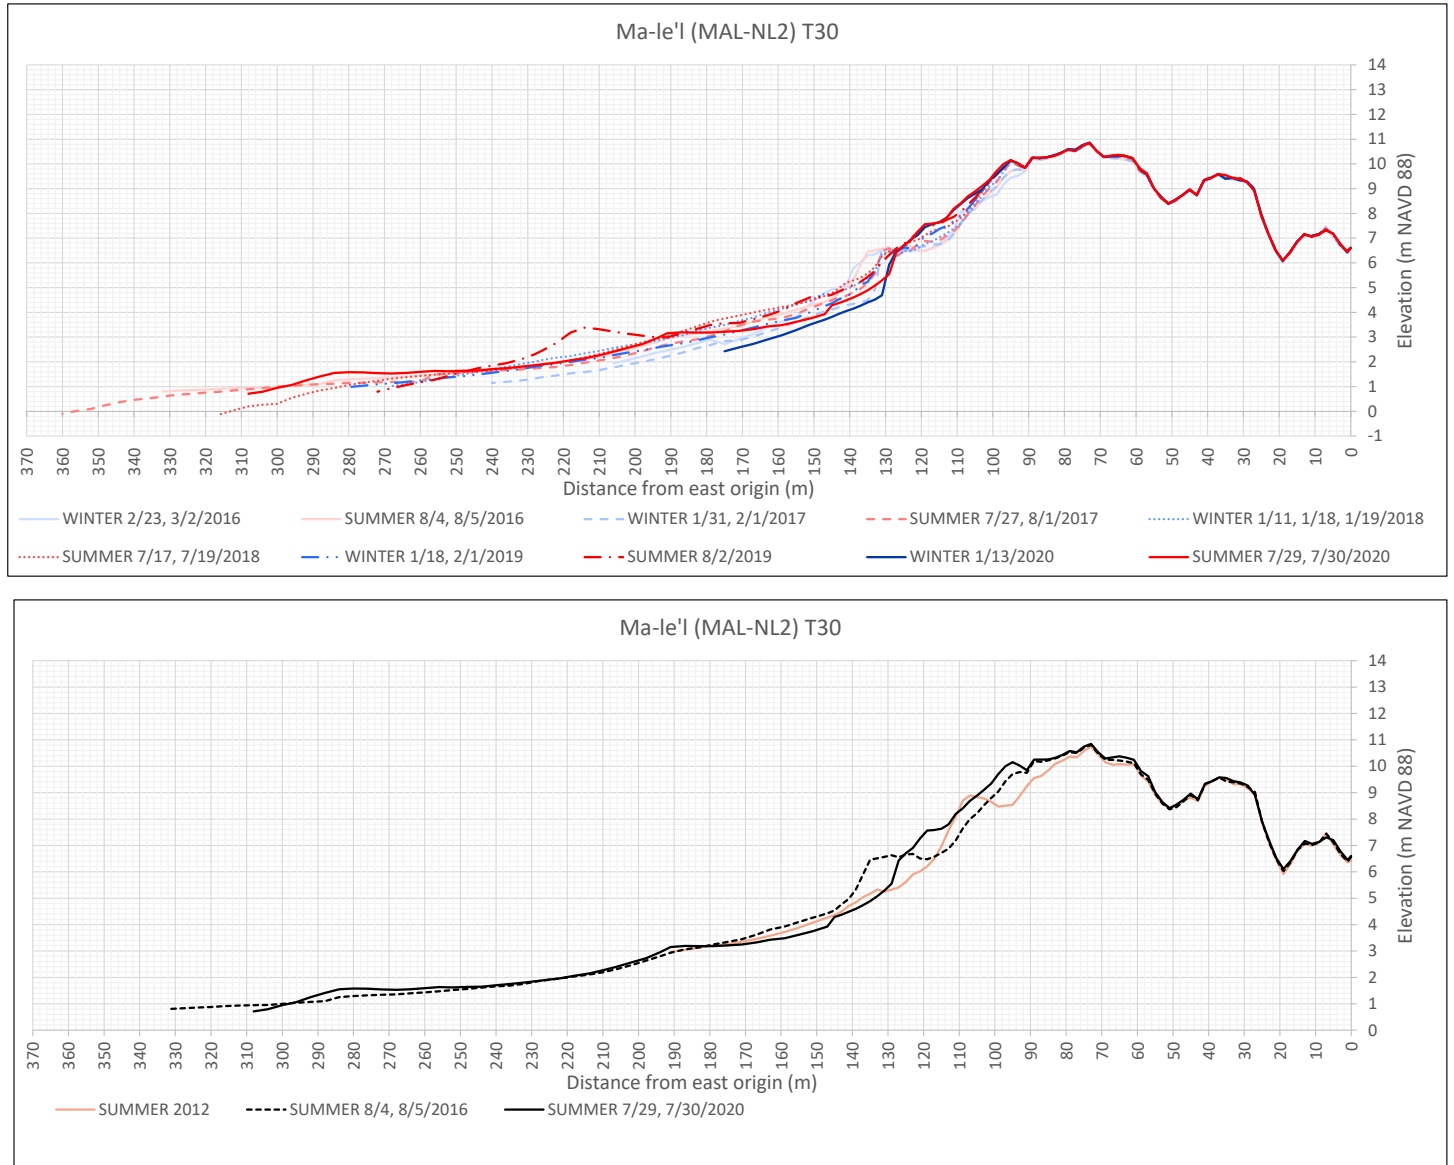
## Ma-le'I North Transect 30

Notes: Between 2012 and 2016 an incipient foredune formed. The incipient *Elymus* foredune scarped dramatically in winter 2017, losing 2.0 m vertically and lowering the beach. By summer 2017 the beach had regained the lost elevation and the incipient foredune slope was smoothed by erosion and ramping. The small peak at 109 m midway up the stoss face of the established foredune in winter 2016 is the relict of a knoll that eroded during the previous 3 years. The sand from the knoll moved up the face of the established foredune. By summer 2018 the incipient foredune was no longer a distinct feature, having welded on to the stoss face of the established foredune. By 2019 this feature had migrated up the foredune. Over the course of both studies the incipient foredune formed and then eroded/translated causing deposition of up to 1 m on the stoss slope of the foredune.

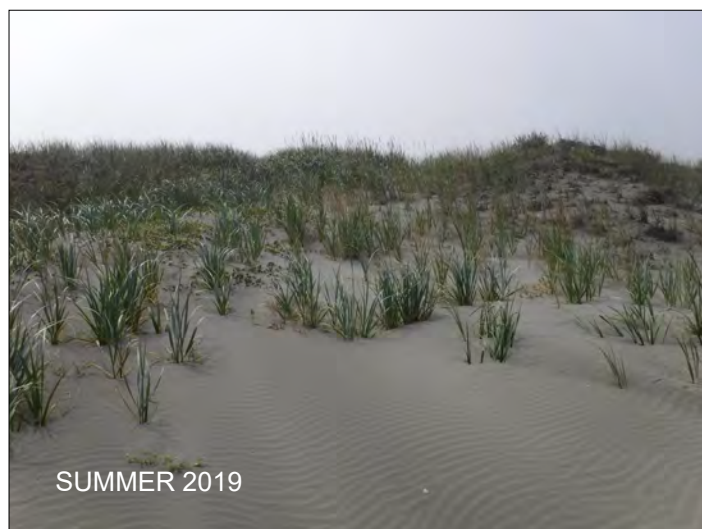
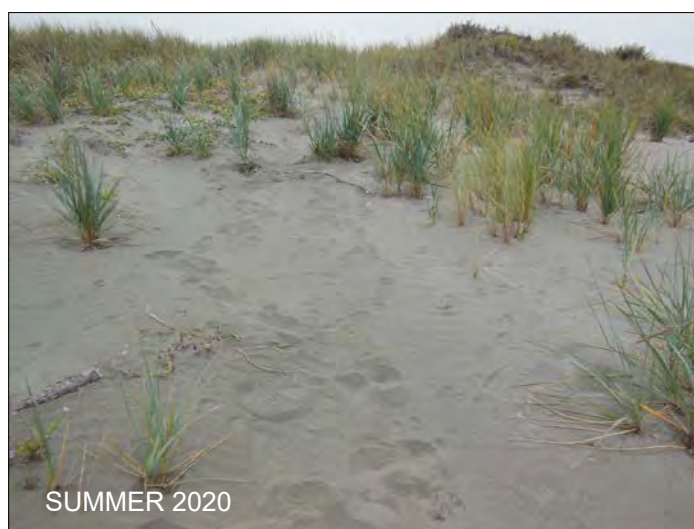
## Ma-le'l North Transect 30

View southeast along transect at 117 m foredune base showing deposition on stoss face

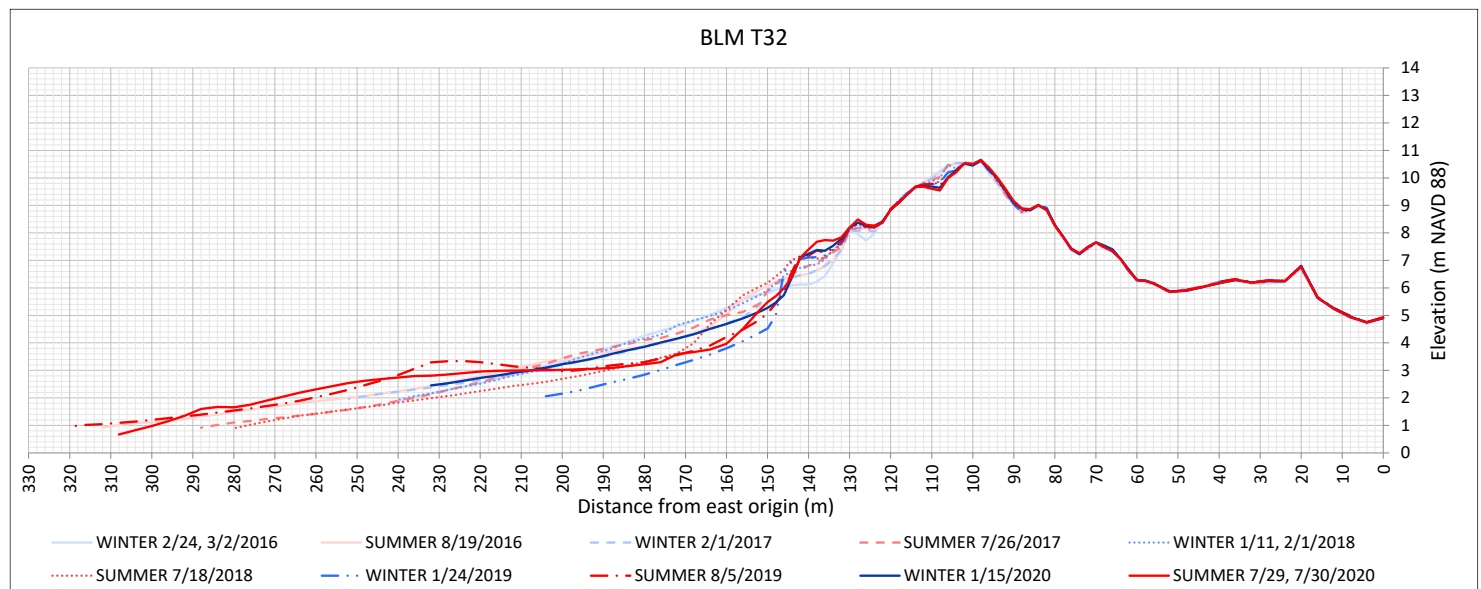
## Ma-le'I South Transect 32

Notes: The broad, bench-like incipient foredune (similar to the previous transect) was scarped in winter 2016 and a steep beach slope resulted. In summer 2016 mobilized sand at the crest of the incipient foredune migrated into the incipient foredune swale and there was 0.5 m of deposition as the result of scarp-fill ramping. In winter 2017 the upper beach scarped and eroded. By summer 2017 sand had filled the scarp and deposition occurred on the incipient foredune. Additional deposition on the incipient foredune occurred by summer 2018, although erosion occurred on the upper beach. In 2019 the incipient foredune and upper beach were substantially scarped, as is visible in the photo below. By Summer 2020 a ramp had formed filling the scarp. Over the course of the study the incipient foredune was removed, retreating 20.0 m, but deposition occurred on the upper stoss face of the established foredune. There was also erosion at the crest.

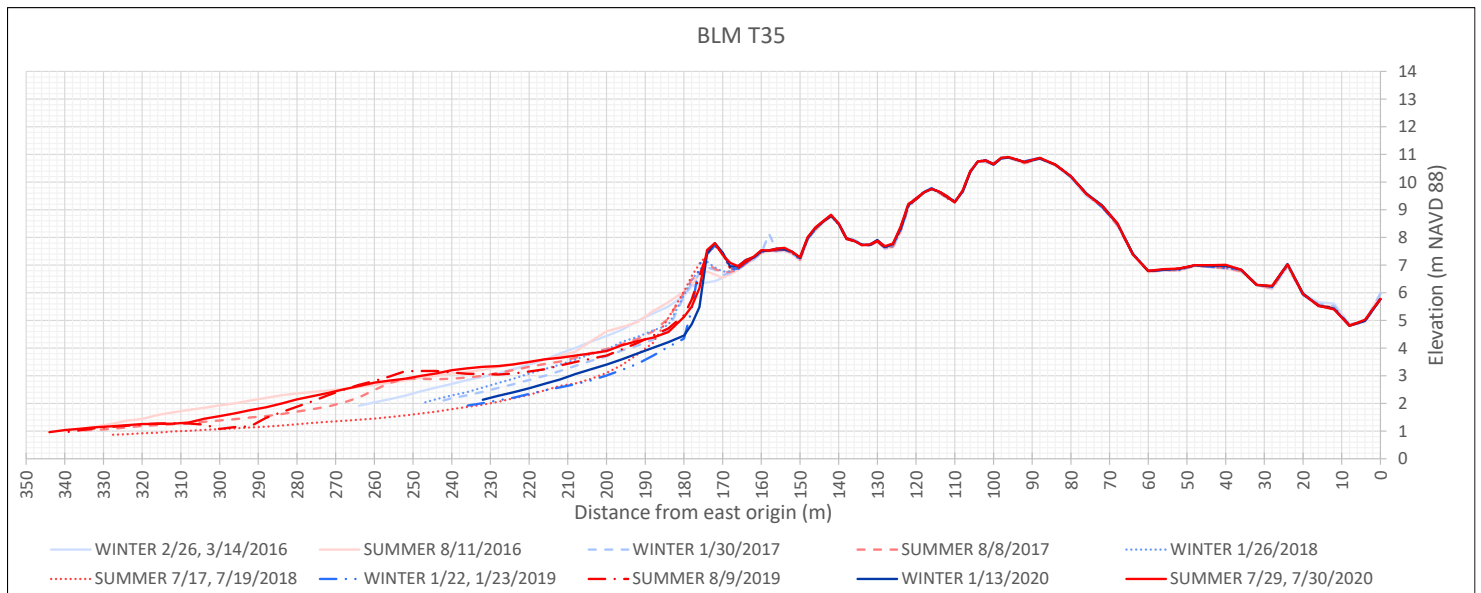
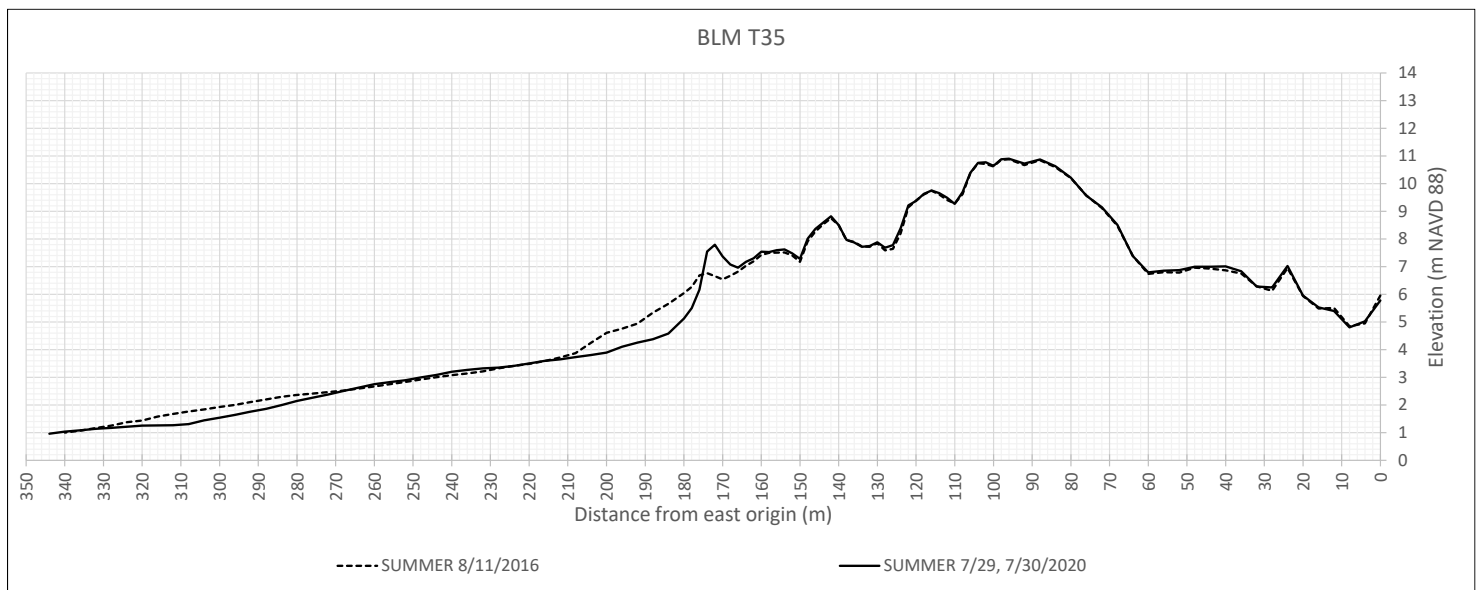
## Ma-le'I South Transect 35

Notes: Through summer 2016 a wide, hummocky incipient foredune sloped gradually from the upper beach to the established foredune. In winter 2017 high water events carved a 1.2 m scarp, creating a more defined incipient foredune. The beach was lowered by 1.0 m and the incipient foredune retreated 15.0 m. Sand was mobilized on the crest of the incipient foredune, forming a slipface that partially buried *Elymus*. During winter 2018 the incipient foredune rescarped, and between the winter and summer 2018 surveys, additional beach erosion lowered the upper beach by 1.0 m, however a scarp fill ramp had formed (see photos) and 0.5 m of deposition occurred on the crest of the incipient foredune by summer 2018. In summer 2019 the incipient foredune had translated inland and increased in elevation. This morphology remained through summer 2020. Over the course of the study the foredune retreated 15.0 m.

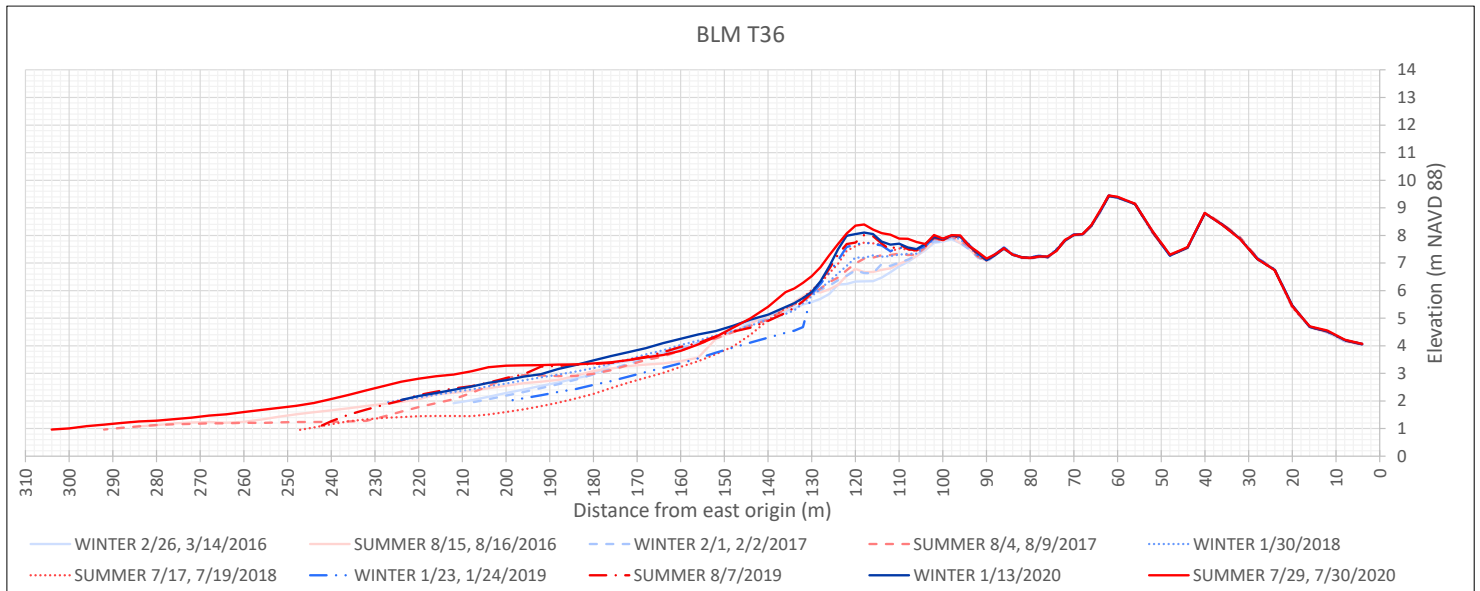
## Ma-le'l South Transect 36

Notes: A wide, hummocky incipient foredune sloped gradually from the upper beach to the established foredune from winter 2016 through summer 2016. The beach remained relatively stable. In summer 2017 the incipient foredune built seaward, with 0.2 m of deposition at its western edge, which is visible in the rear of the left photograph taken from the crest of the incipient foredune looking northwest along the transect. There was little change during winter 2018, and in summer 2018 the incipient foredune had an additional .5 m of deposition (see photo), while the upper beach was eroded an equivalent amount. There was little change in 2019. By summer 2020 there was additional deposition on the incipient foredune. Over the course of the study the incipient foredune gained up to 1.5 m in elevation and welded to the foredune.

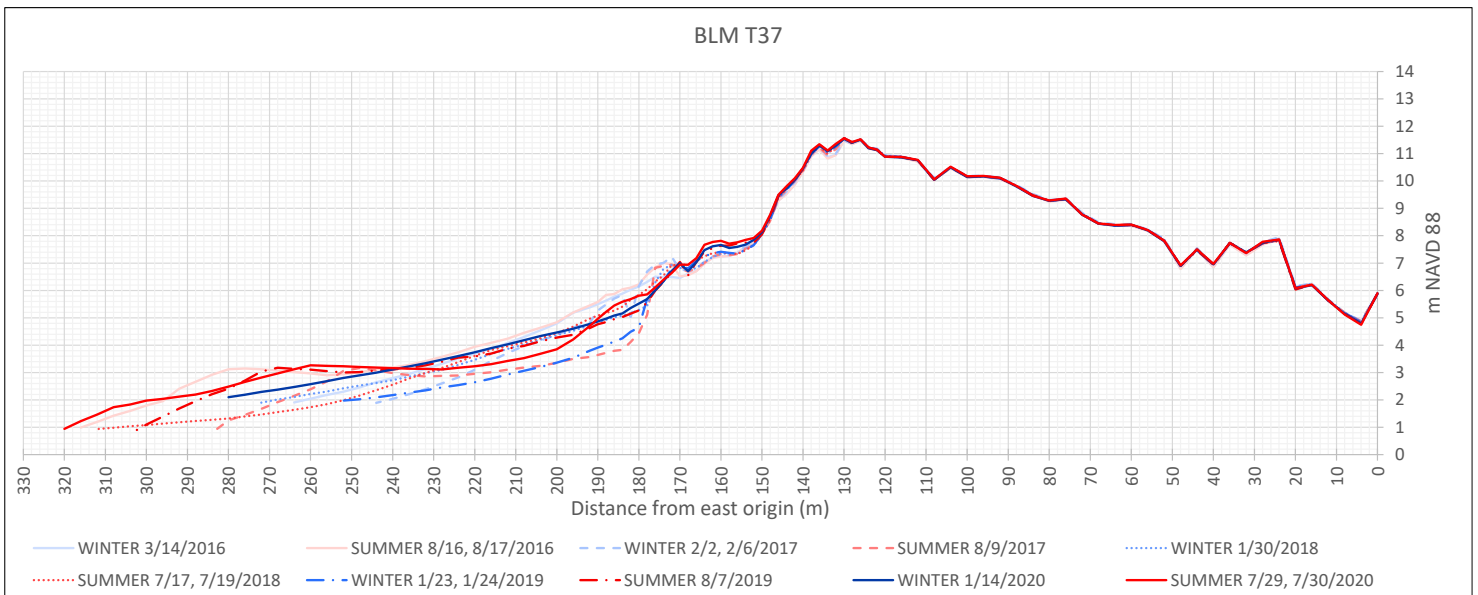
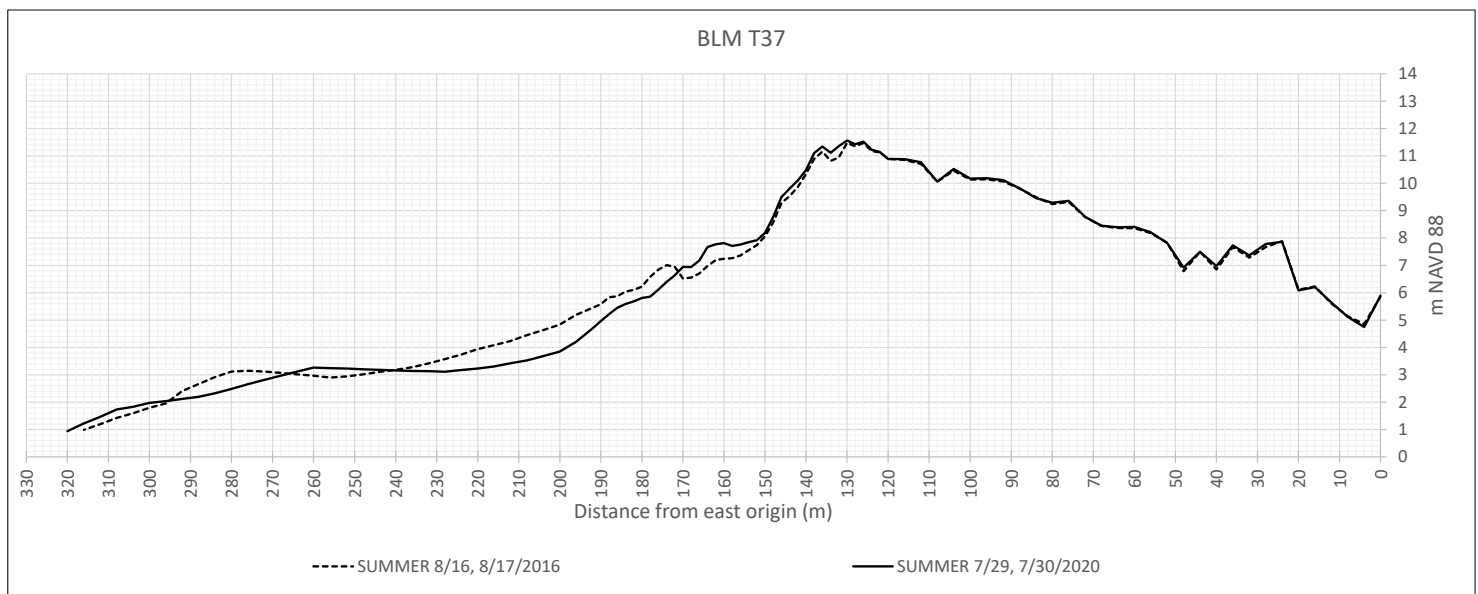
## Ma-le'i South Transect 37

Notes: The broad, native established foredune at this site sloped gradually to the backshore in winter 2016, and in summer 2016 an incipient foredune formed with the deposition of 0.5 m on the backshore. The incipient foredune was then eroded during winter 2017 leaving a 1.0 m scarp and the loss of 0.5 m of upper beach. The deep incision in the profile is caused by the oblique transect crossing two sides of an eroded cusp in the incipient foredune. Additional scarping and beach lowering occurred after the survey during winter 2017. This shows up in the summer 2017 profile as a 3.0 m scarp and 12.0 m of horizontal retreat. The beach remained low during the summer, with high tides in August reaching the bottom of the scarp. However, by summer 2018 a scarp-fill ramp had formed and over 1.0 m of deposition occurred on the upper beach, returning the profile to a condition similar to 2016. In 2019 the incipient foredune increased 0.3 m in elevation, translating inland, and the scarp healed. In summer 2020 there was additional deposition. Over the course of the study the incipient foredune translated up and east, retreating 10.0 m, and deposition occurred on the stoss face of the established foredune.

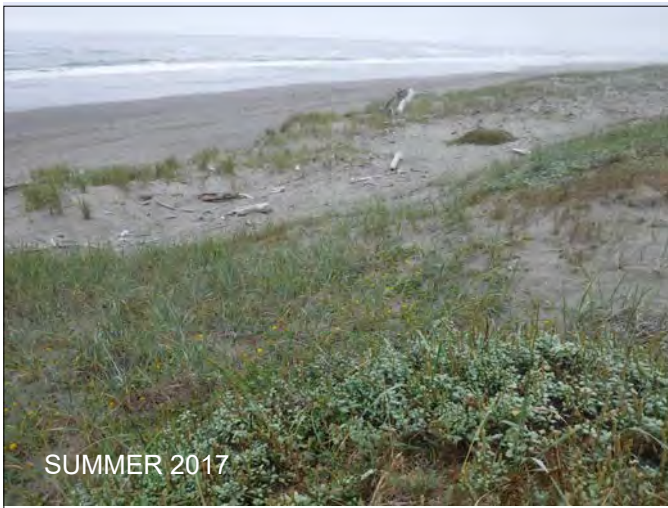
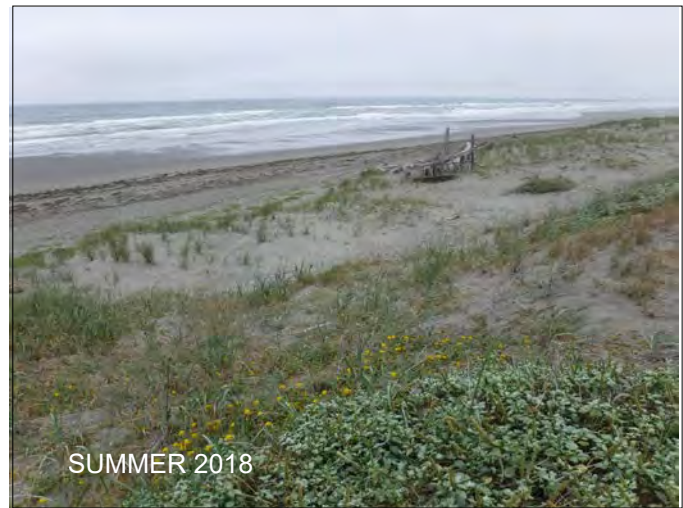
## Ma-le'I South Transect 37

View southeast along transect from foredune crest at 136 m
