# HUMBOLDT COASTAL RESILIENCY PROJECT AND CLIMATE READY PROJECT

## SUMMARY DATA FOR CROSS-SHORE TRANSECTS WINTER 2016-SUMMER 2020

Andrea Pickart and Candace Reynolds, U.S. Fish and Wildlife Service,  
and Ian Walker, U.C. Santa Barbara

July 2021

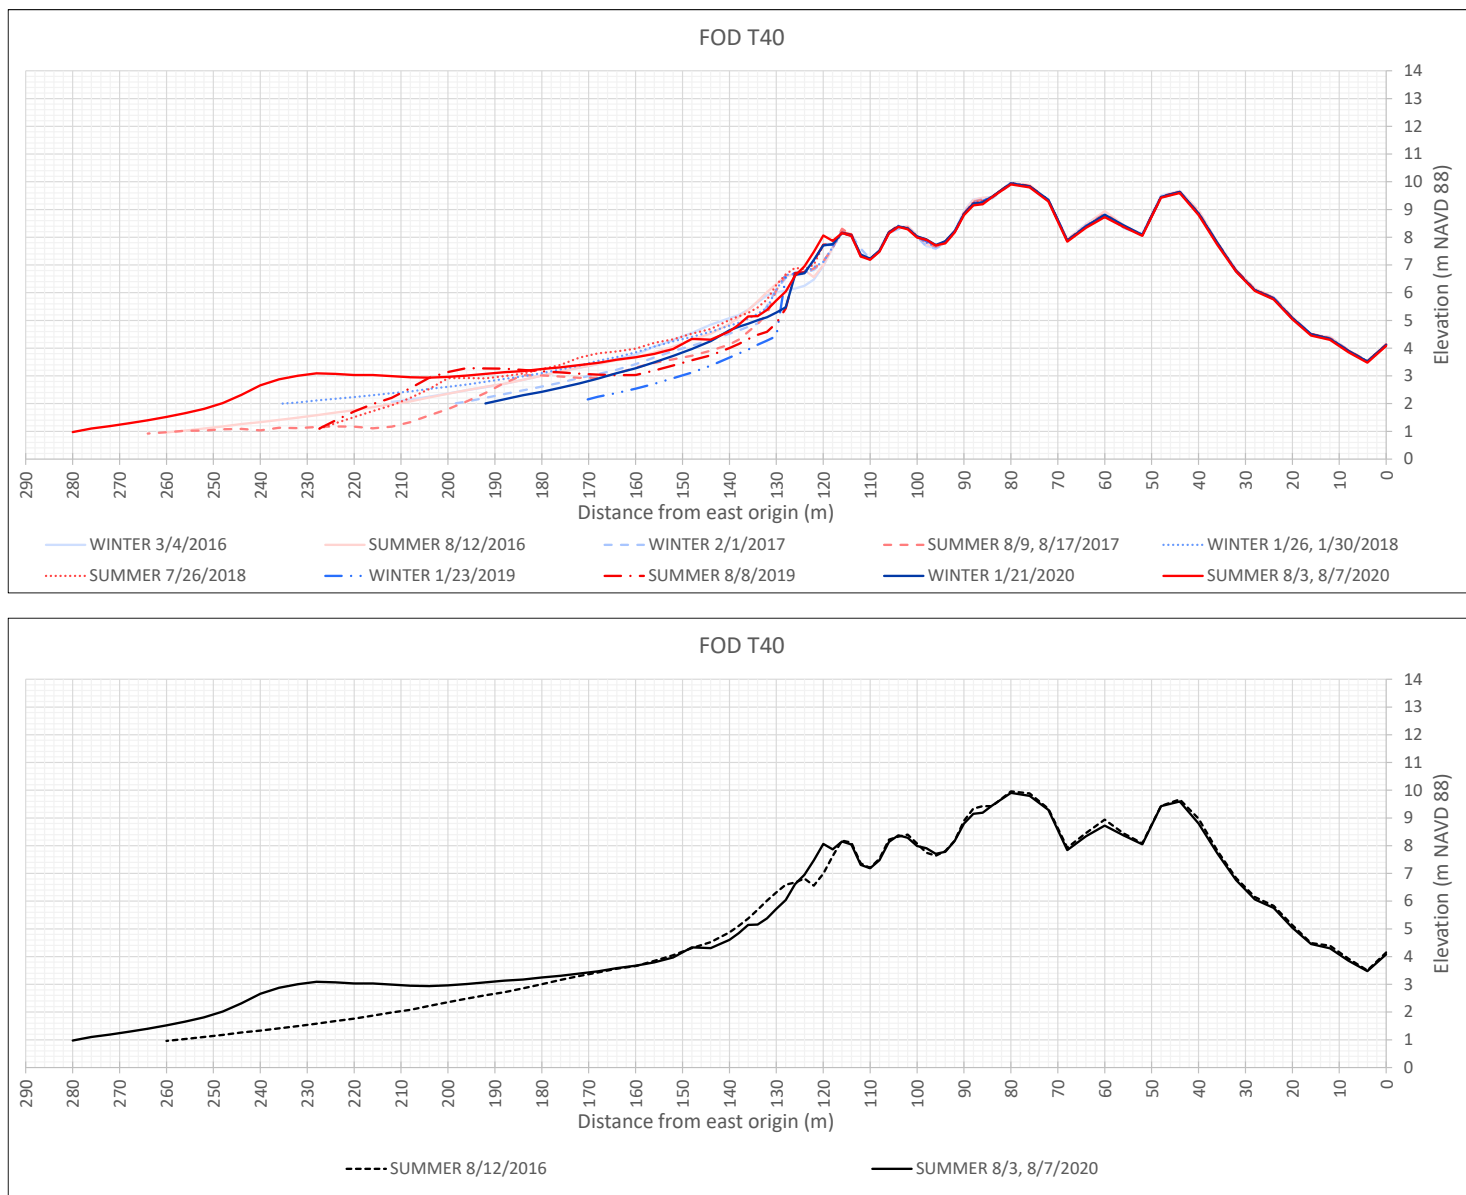
## FOD Transect 40

Notes: The profile depicts multiple incipient and established foredunes built by *Ammophila*, although the area behind the first persistent incipient foredune (crest at 115 m) has undergone *Ammophila* removal. Between winter 2016 and summer 2016 deposition of 0.5 m occurred on the upper beach, creating a new sparsely vegetated *Ammophila* incipient foredune (crest at 125 m). This incipient foredune was then scarped in winter 2017 and the beach eroded, emphasizing the incipient foredune topography although its crest elevation was unchanged. Some slumping had occurred by summer 2017 (see left photograph looking inland along transect from upper beach) but the incipient foredune profile did not change. By summer 2018 a scarp-fill ramp had formed (top right photo). The feature was again scarped in winter 2019, with some recovery in summer 2019. By summer 2020 a scarp fill ramp had formed. Over the course of the study the outer incipient foredune was eroded, retreating 2.0m, and the more inland incipient foredune increased in breadth (prograding 2.5 m) due to ramp formation.

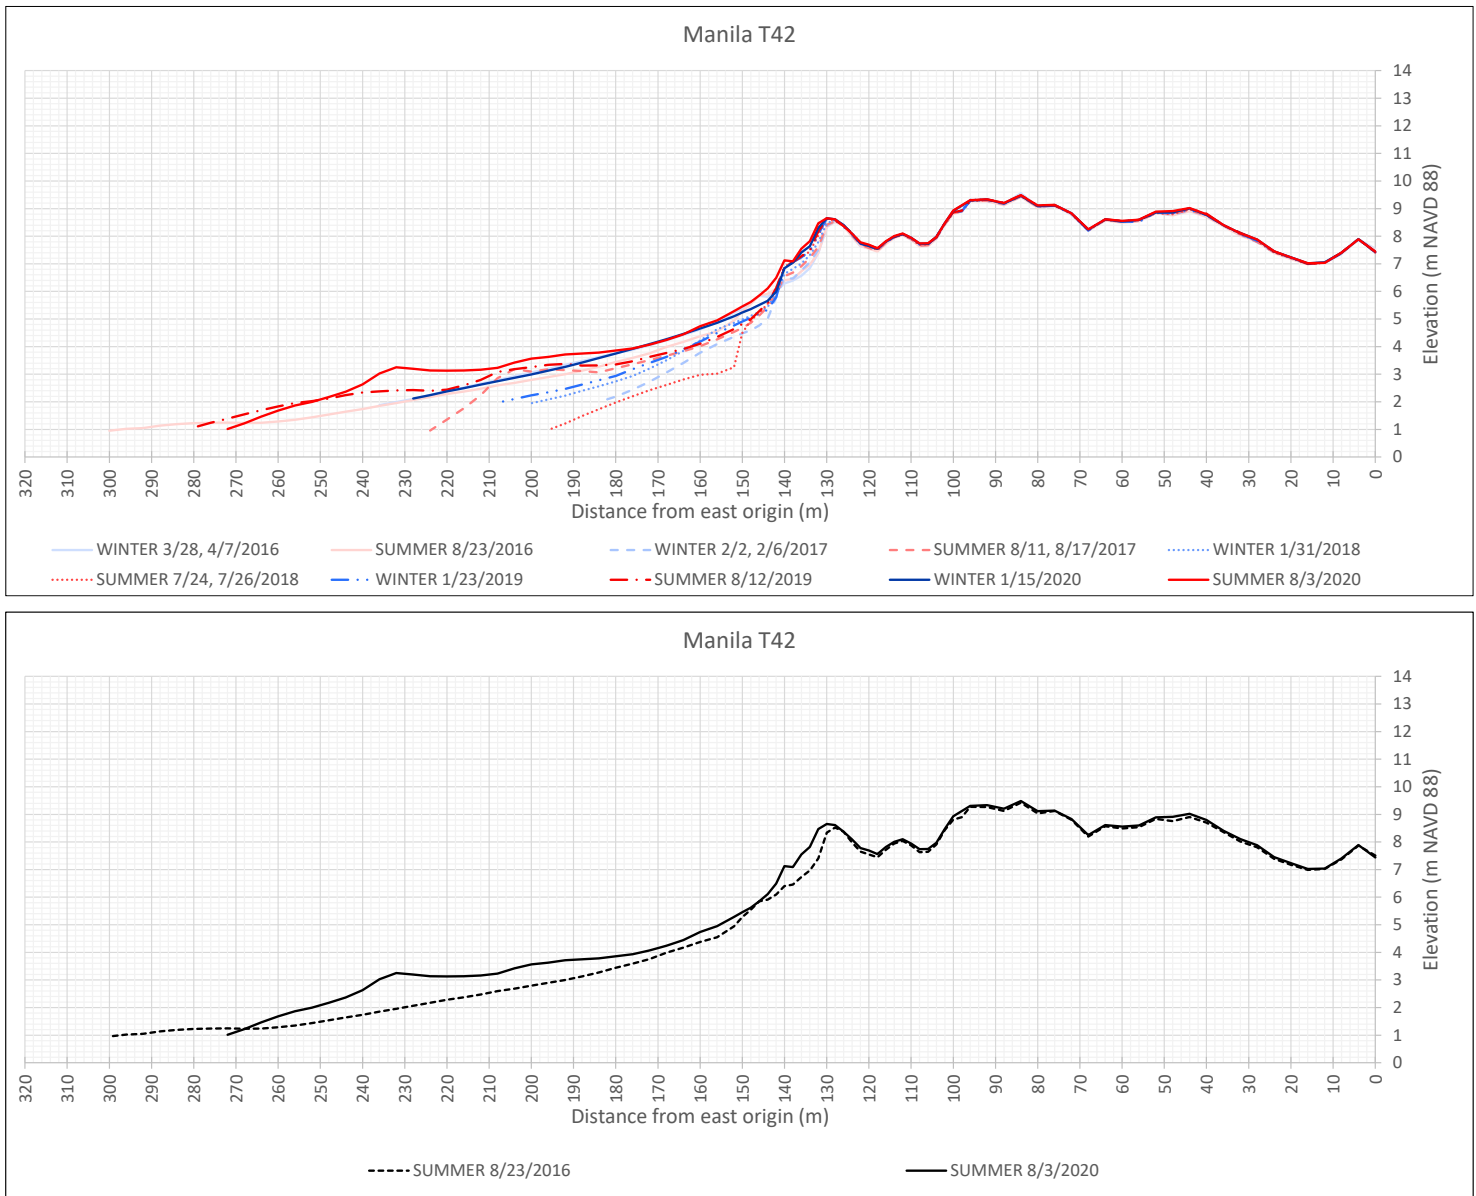
## MCSD Transect 42

Notes: The transect is located in the Manila Dunes Recreation Area. The area was re-stored in the 1990s-2000s, but was not maintained, and *Ammophila* has reinvaded the foredune zone. An incipient foredune was forming in summer 2016, but was scarped in the high water events of winter 2017, losing 1.0 m vertically and retreating 10.0 m horizontally along the oblique transect. While scarp-fill ramping smoothed the upper beach profile by summer 2017, elevation of the upper beach was still 0.8 m below the previous year's elevation and the incipient foredune had not rebuilt. Between winter and summer 2018 surveys the lower beach scarped dramatically, resulting in the loss of up to 1.0 m elevation (see photos below). By summer 2019 a new scarp fill ramp had established (see photo below) and by summer 2020 there was deposition of up to 0.5 m on the stoss face of the established foredune. Over the course of the study the incipient foredune eroded, retreating 10.0 m, and the foredune saw accretion of 0.5 m on the stoss face.

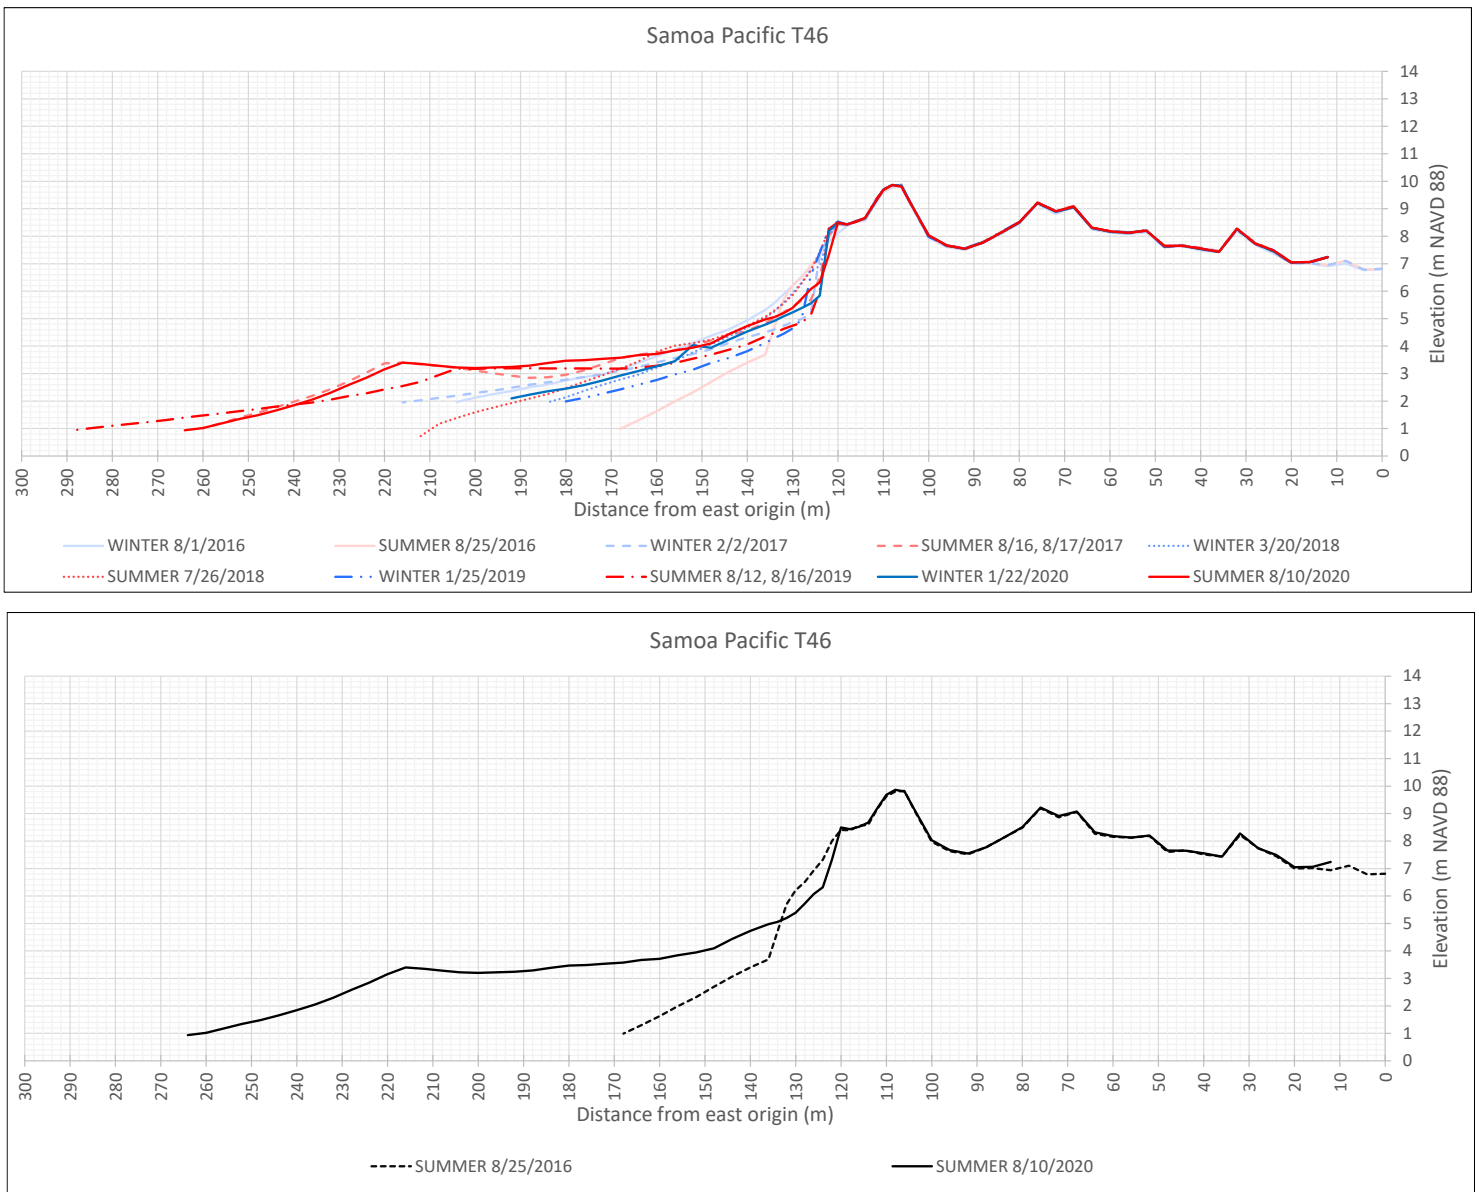
## Samoa Pacific Transect 46

Notes: The transect describes a steep *Ammophila* foredune (crest 106 m) with a relict native (now invaded) foredune at 76 m. The base of the foredune was scarped between the winter and summer 2016 surveys, resulting in beach lowering of 1.5 - 2.0 m. In winter 2017 the foredune was further scarped, retreating 10 m horizontally and removing 2.2 m vertically. From winter to summer 2017 there was upper beach deposition, with a scarp-fill ramp beginning to form, and minor deposition at the crest of the scarp. By summer 2018 the stoss face was completely ramped and had recovered the foredune morphology present in 2016. In 2019 and 2020 additional scarping occurred in winters, resulting in a steep foredune stoss face. Over the course of the study the foredune stoss face retreated 5.0 m but the beach gained in elevation. There is a pattern of winter scarping and summer beach deposition and ramp formation.

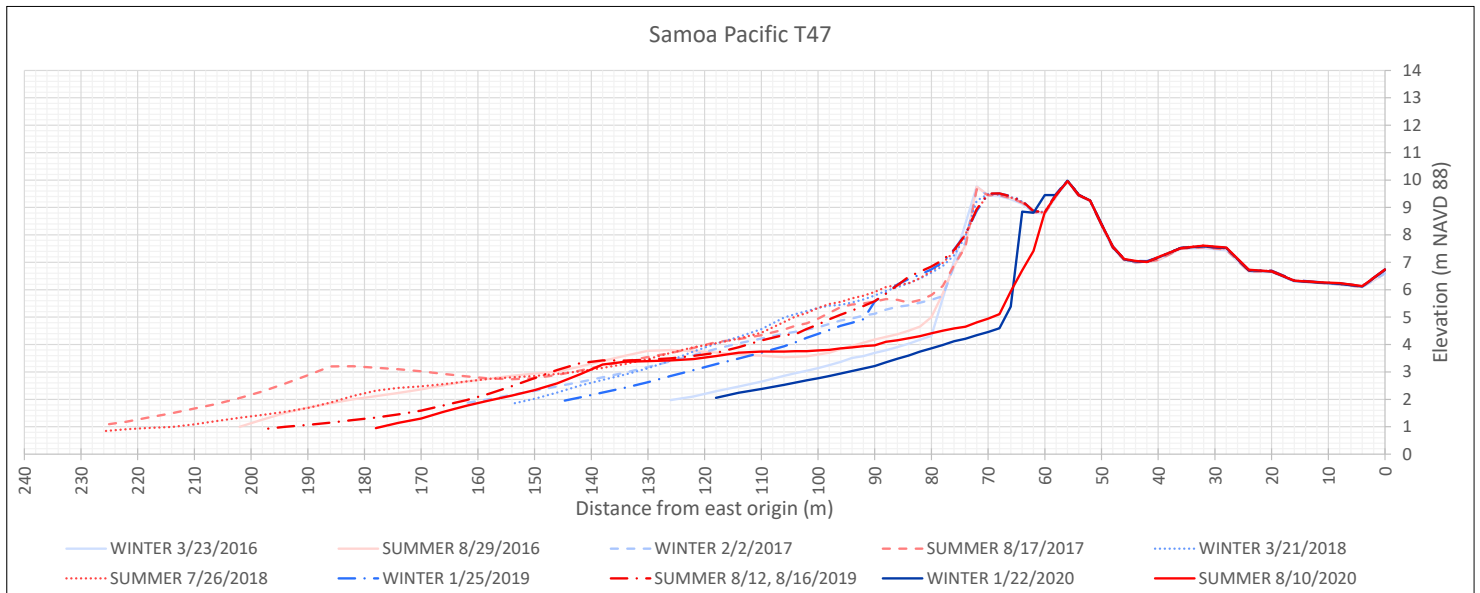
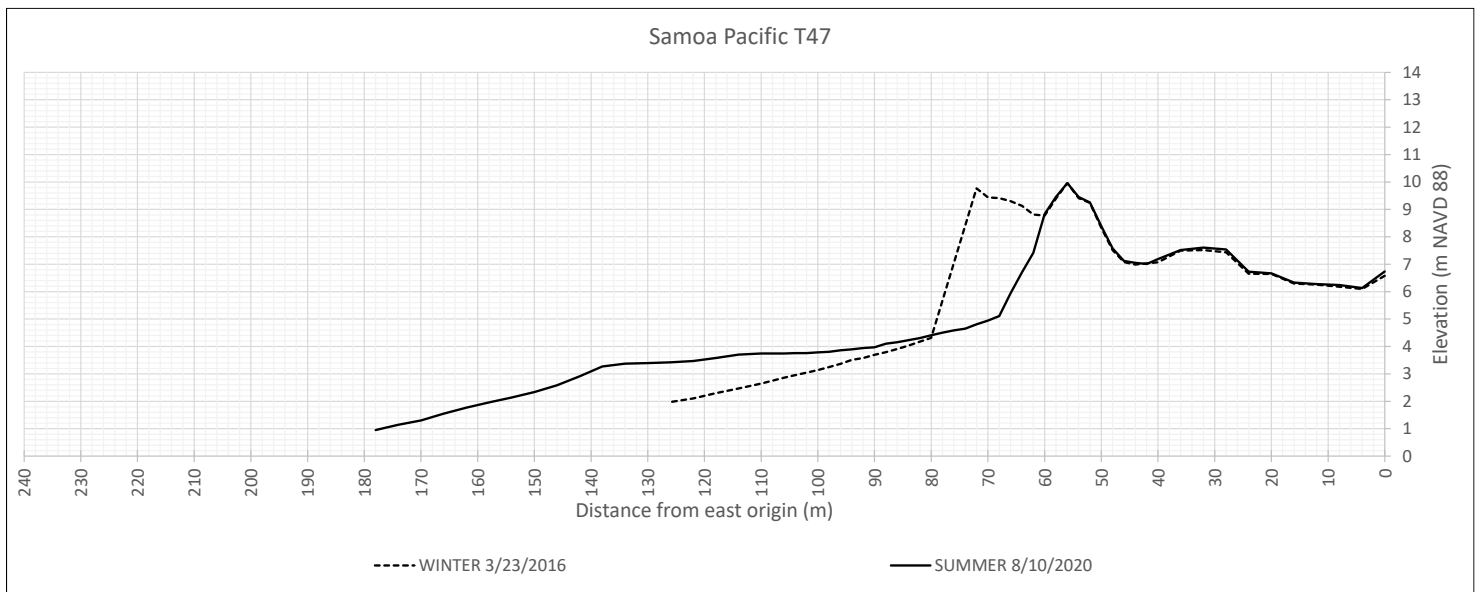
## Samoa Pacific Transect 47

Notes: The transect is composed entirely of dunes that formed since 1939 and under the influence of *Ammophila* rather than native vegetation. The established *Ammophila* foredune was severely scarped prior to the winter 2016 survey, leaving a 5.0-m vertical scarp and presumably lowering the beach. The beach gradually recovered 2+ m of elevation. By summer 2018 a scarp-fill ramp had formed, and was present in similar proportions in summer 2019. In winter 2019 the foredune was scarped again and retreated 15 m., lowering the beach. In summer 2020 the beach gained some in elevation. Over the course of the study the foredune retreated 15 m.

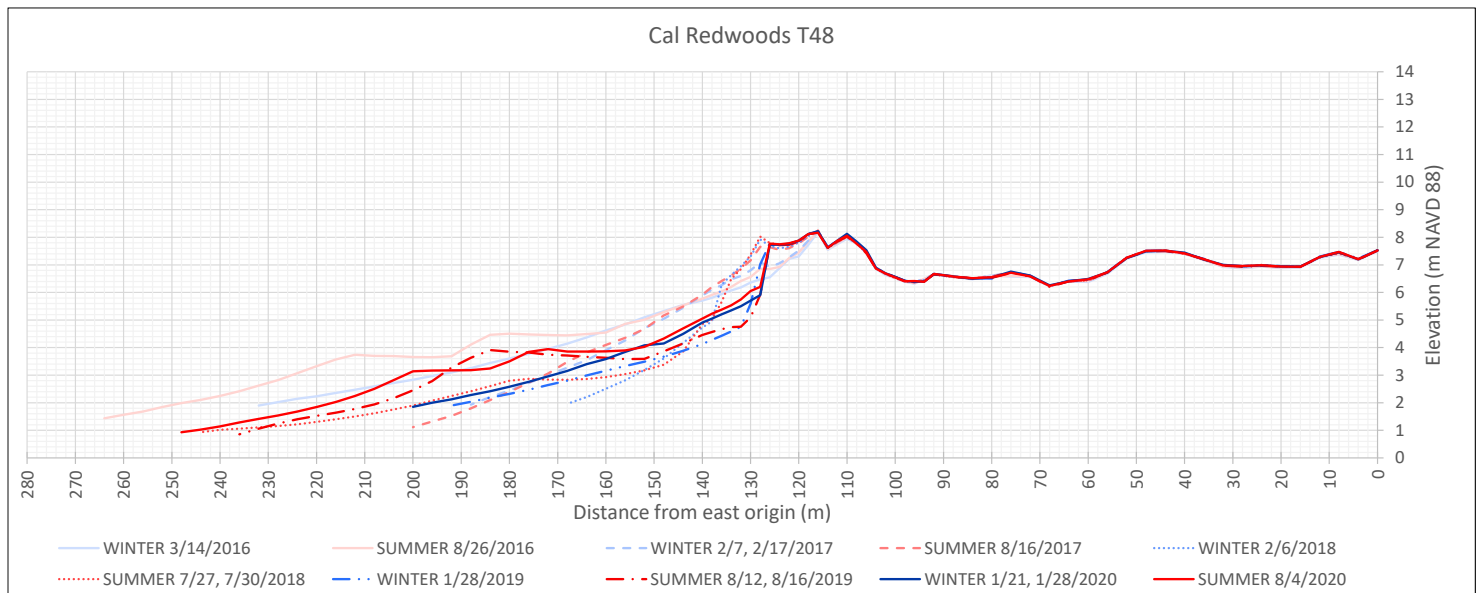
## Cal Redwoods Transect 48

Notes: The profile describes a low *Ammophila* foredune in front of a lower backdune area. Deposition of 0.4 m occurred on the backshore in summer 2016 suggesting the start of an incipient foredune, along with up to 1.0 m seasonal deposition on the beach at 184 m. Erosion in winter 2017 removed substantial sediment from the beach (2.2 m at 184 m), creating a steeply sloping beach. However, some deposition occurred on the incipient foredune. In summer 2017 the beach did not increase in elevation, but there was 0.8 m deposition on the crest of the incipient foredune, essentially merging it with the established foredune. In winter 2017 scarping removed 2.0 m of vertical sediment from the backshore (see photo below right) and very little change occurred between winter and summer 2018 other than deposition in the foreshore. In winter 2019 additional scarping occurred. By summer 2020 ramping/slumping had occurred but the top portion of the foredune was still scarped. Over the course of the study the foredune broadened, with 0.7 m of deposition on the crest, but assumed a scarped morphology.

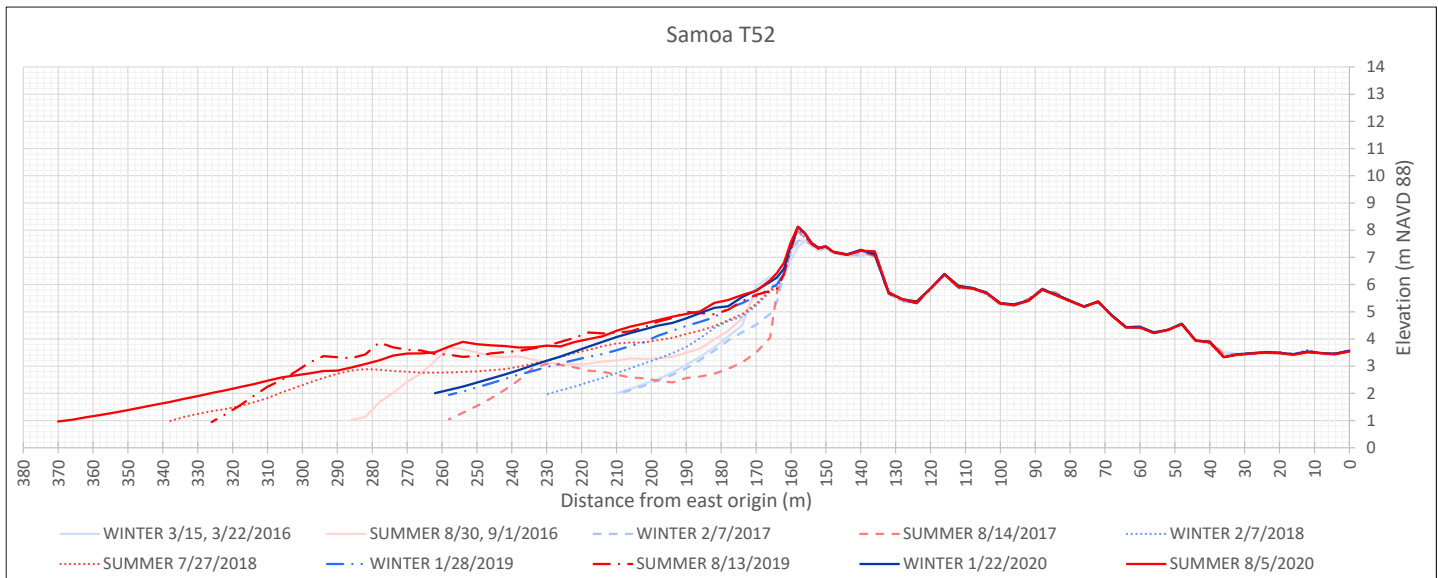
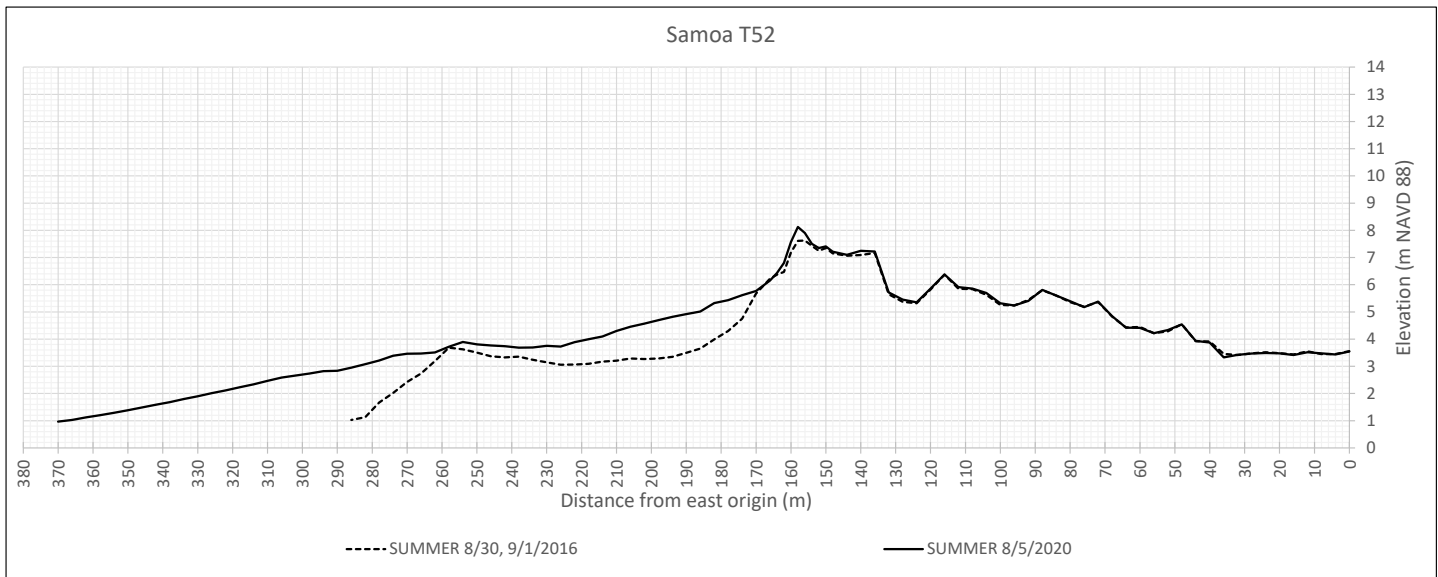
## Samoa Transect 52

Notes: The transect is within the Samoa Dunes Recreation area and crosses several ATV trails that bisect an area stabilized by *Ammophila*. This is also an area of continuing high erosion since at least the 1930s, influenced by its proximity to the north jetty. In winter 2016 the backshore was characterized by a bench-like feature that may have been caused by beach scarping prior to the survey. In summer 2016 1.0 m of sediment was deposited below the bench. In winter 2017 the backshore was scarped and the bench removed, losing 1.0 m vertically and retreating 10.0 m horizontally. Additional erosion occurred after the survey, lowering the beach by another meter at the base of the foredune in the summer 2017 profile. By summer 2018 1.5 m of deposition had occurred on the backshore, returning the profile to near 2016 levels. In summer 2019 deposition of up to 1.0 m occurred on the backshore, bringing it to its highest elevation since monitoring began. In summer 2020 the profile remained at approximately 2019 levels. Over the course of the study, there was net deposition on the foreshore and backshore. The foredune remained static except for deposition on the crest in 2020.

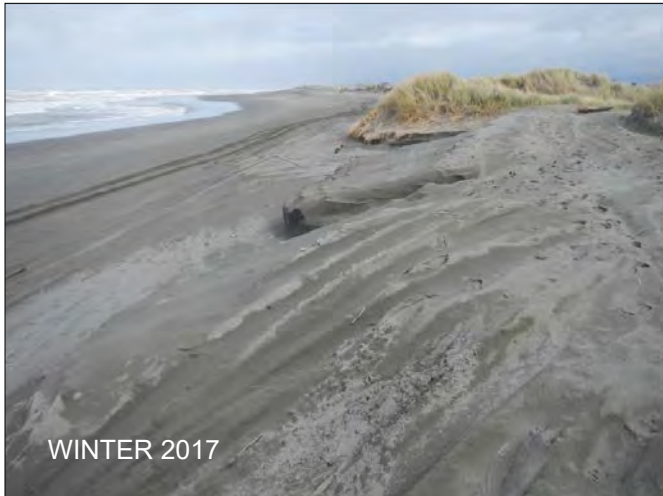
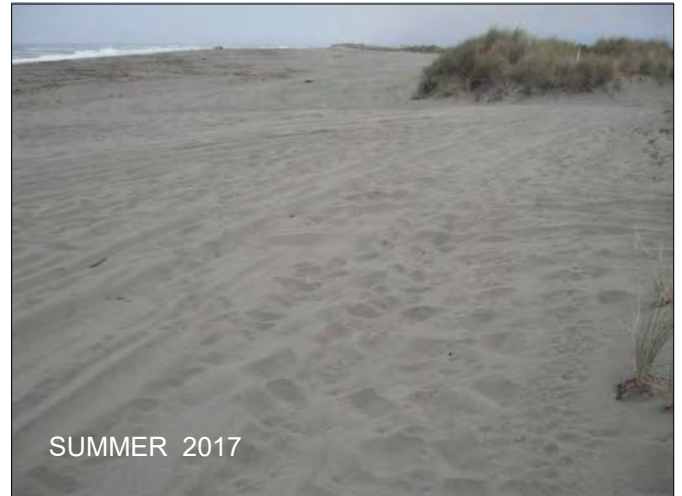
## Samoa Transect 52

View north at 162 m (foredune base)

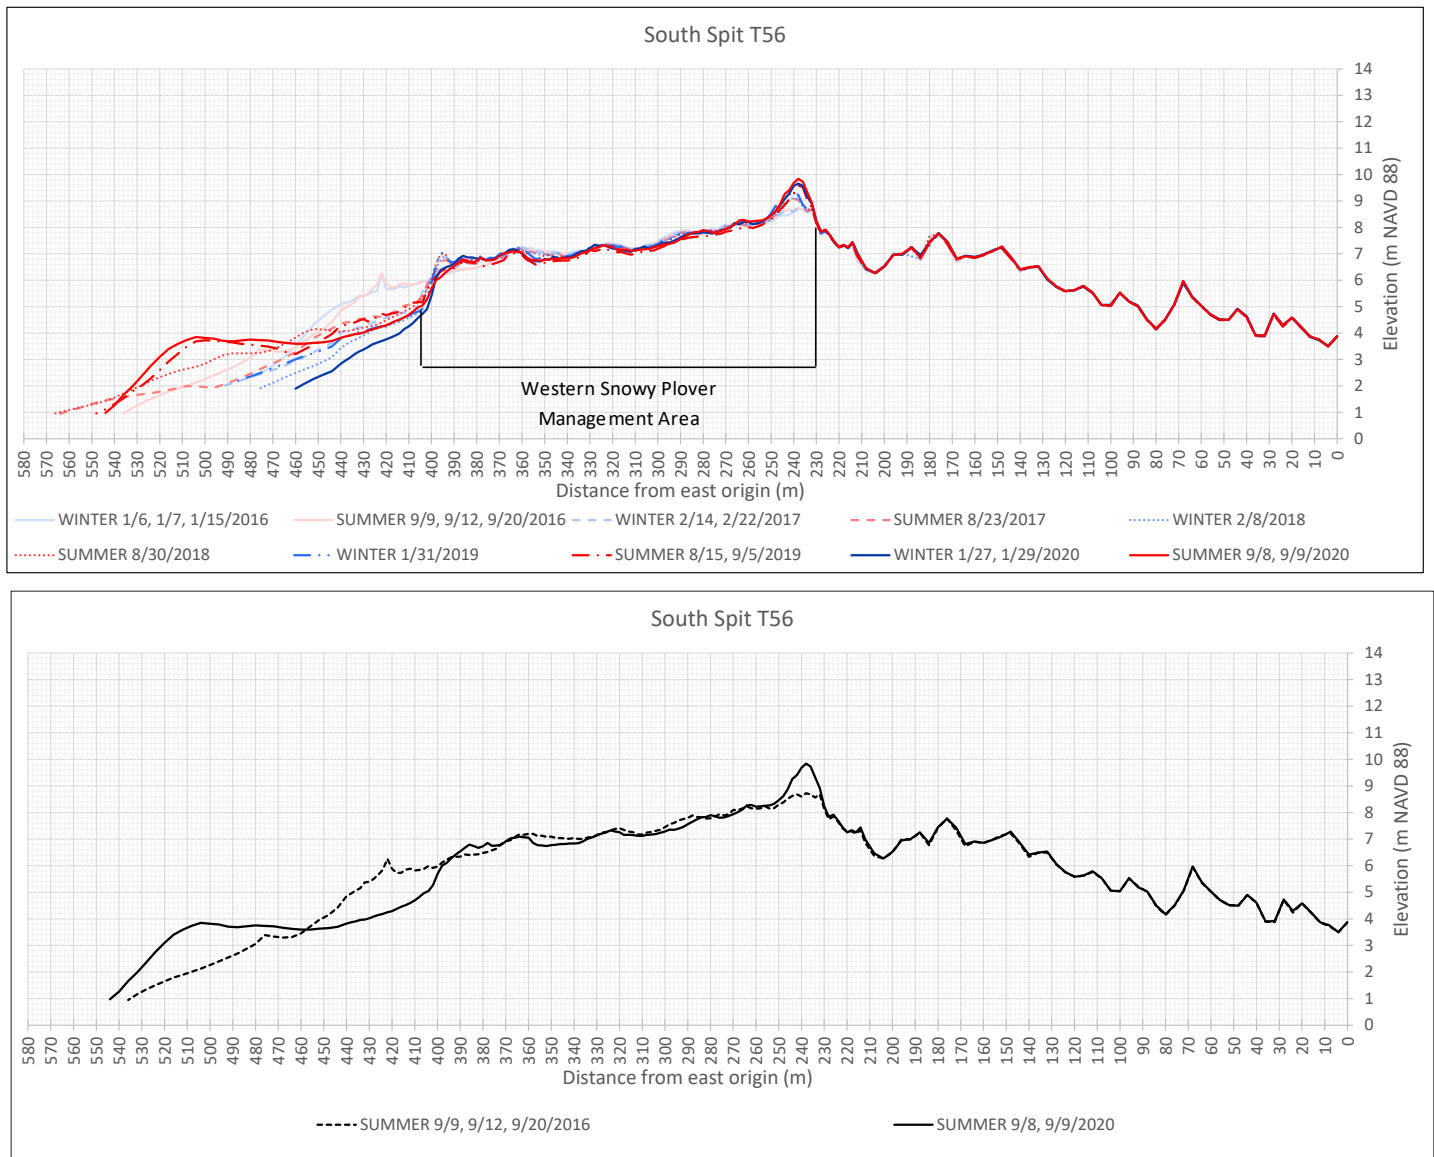
## South Spit Transect 56

Notes: Similar to Transect 55, Transect 56 intersects the BLM's Western Snowy Plover management area. There was more of a foredune in this profile (with a similar feature visible to the north in the photograph which is taken northwest along the transect from the base of the ridge). This feature originated as a wave cut escarpment in winter 2017, and managers did not grade it in 2017. Aeolian deposition occurred on its crest in summer 2017. There was only minor filling of the scarp in summer 2017 and by summer 2018 those sediments had eroded. By summer 2020 the foredune feature had eroded. Similar to T55, there was deposition in summers 2017-2019 at the east end of the management area where dense, unmanaged *Ammophila* begins. In winter 2018 there was erosion on the upper beach and in summer 2019 there was erosion throughout the managed area, which might have been the result of grading. Over the course of the study, the flattened foredune retreated 40.0 m.

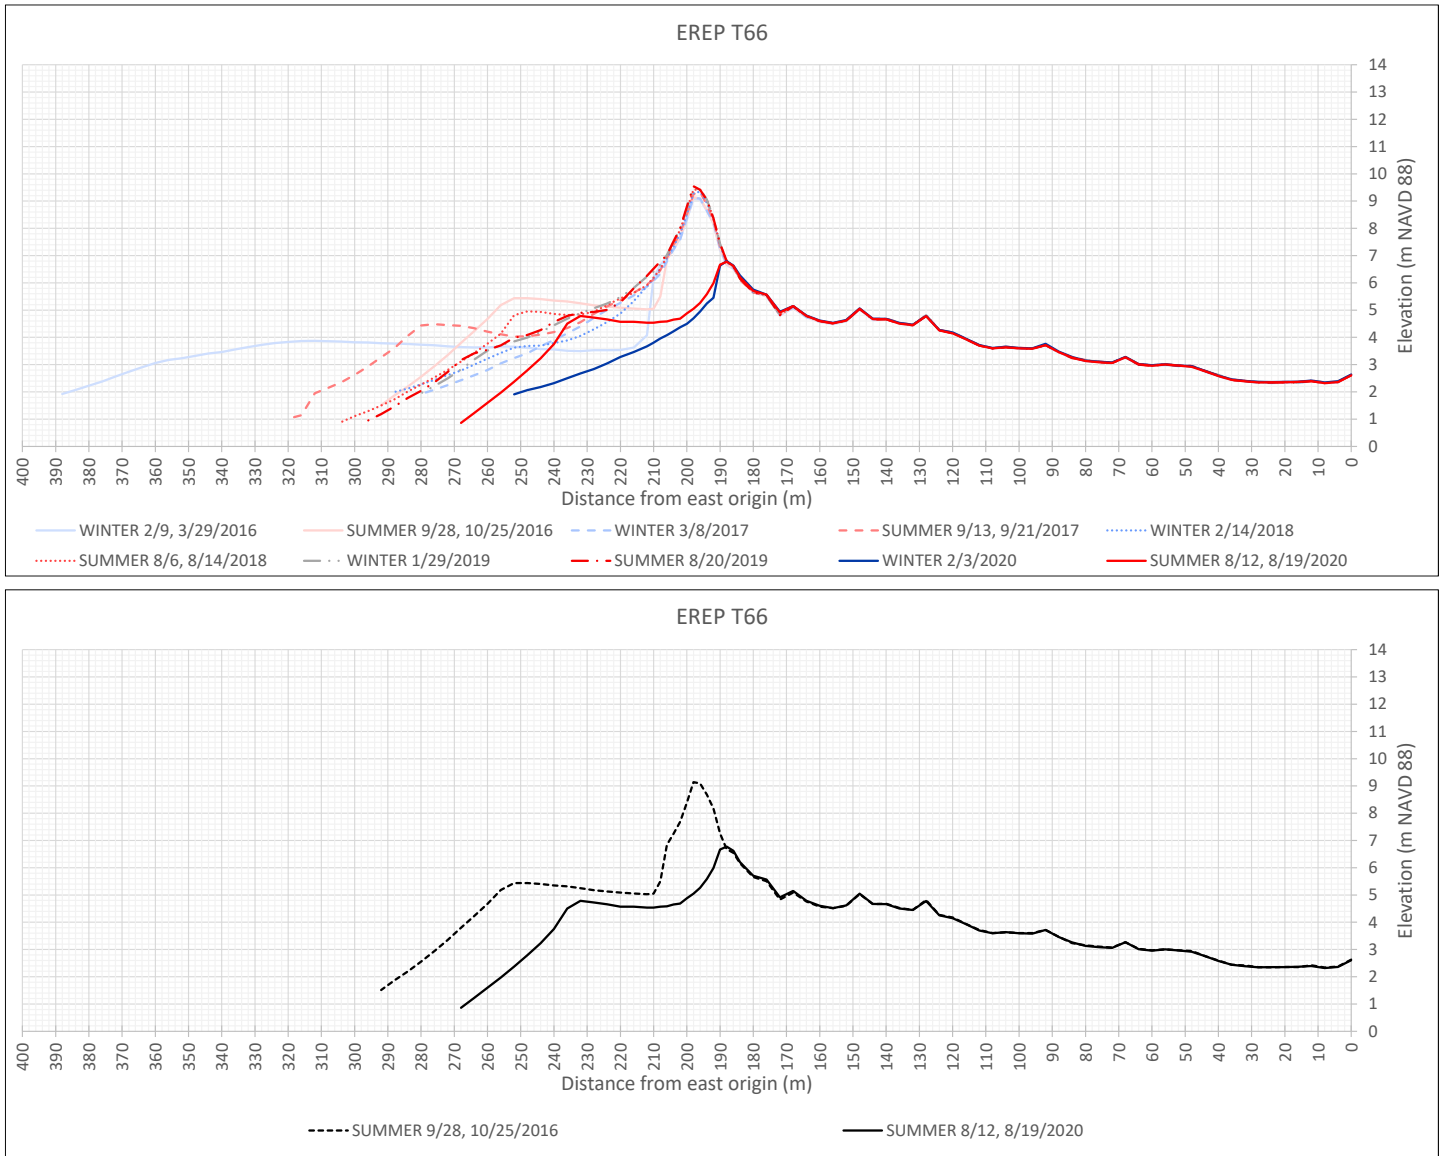
## Eel River Estuary Preserve Transect 66

Notes: This transect is located on the Eel River southern barrier, south of the true spit, and consists of a dynamic beach and a narrow peaked *Ammophila* foredune in front of a low backdune area that slopes down to the estuary. The foredune was scarped in winter 2016 prior to the survey, creating a 2.0-2.5 m drop in elevation. By summer 2016 the foredune had eroded back an additional 0.4 m horizontally, while the backshore regained approximately half of the elevation lost, forming a berm. By the following winter the berm had eroded, but a ramp had formed, creating the smoothly sloping rather steep backshore visible in the photo below (taken from the base of the foredune looking north). By summer 2018 the berm had partially rebuilt on the upper beach. By summer 2019 the berm was no longer present and there was a continuous slope from the upper beach to the foredune. In winter 2020 the foredune was severely scarped during winter storms, losing over 2.0 m in elevation. The profiles suggests a dynamic beach with high rates of annual volumetric change. Over the course of the study the foredune retreated 15.0 m, indicating low resilience and in keeping with the characterization of this stretch of shoreline as medium erosion historically.
